Subject: Millennium Tower
301 Mission Street, San Francisco
Serious Situation Requiring Attention

Subject: Millennium Tower
301 Mission Street, San Francisco
Two Differing Plans for Foundation Retrofitting

This correspondence briefly discusses two foundation plans (external asymmetrical and internal symmetrical) engineered separately for retrofitting support to the subsided and tilted Millennium Tower. This report is provided as a public service as one of the plans seriously affects the City.

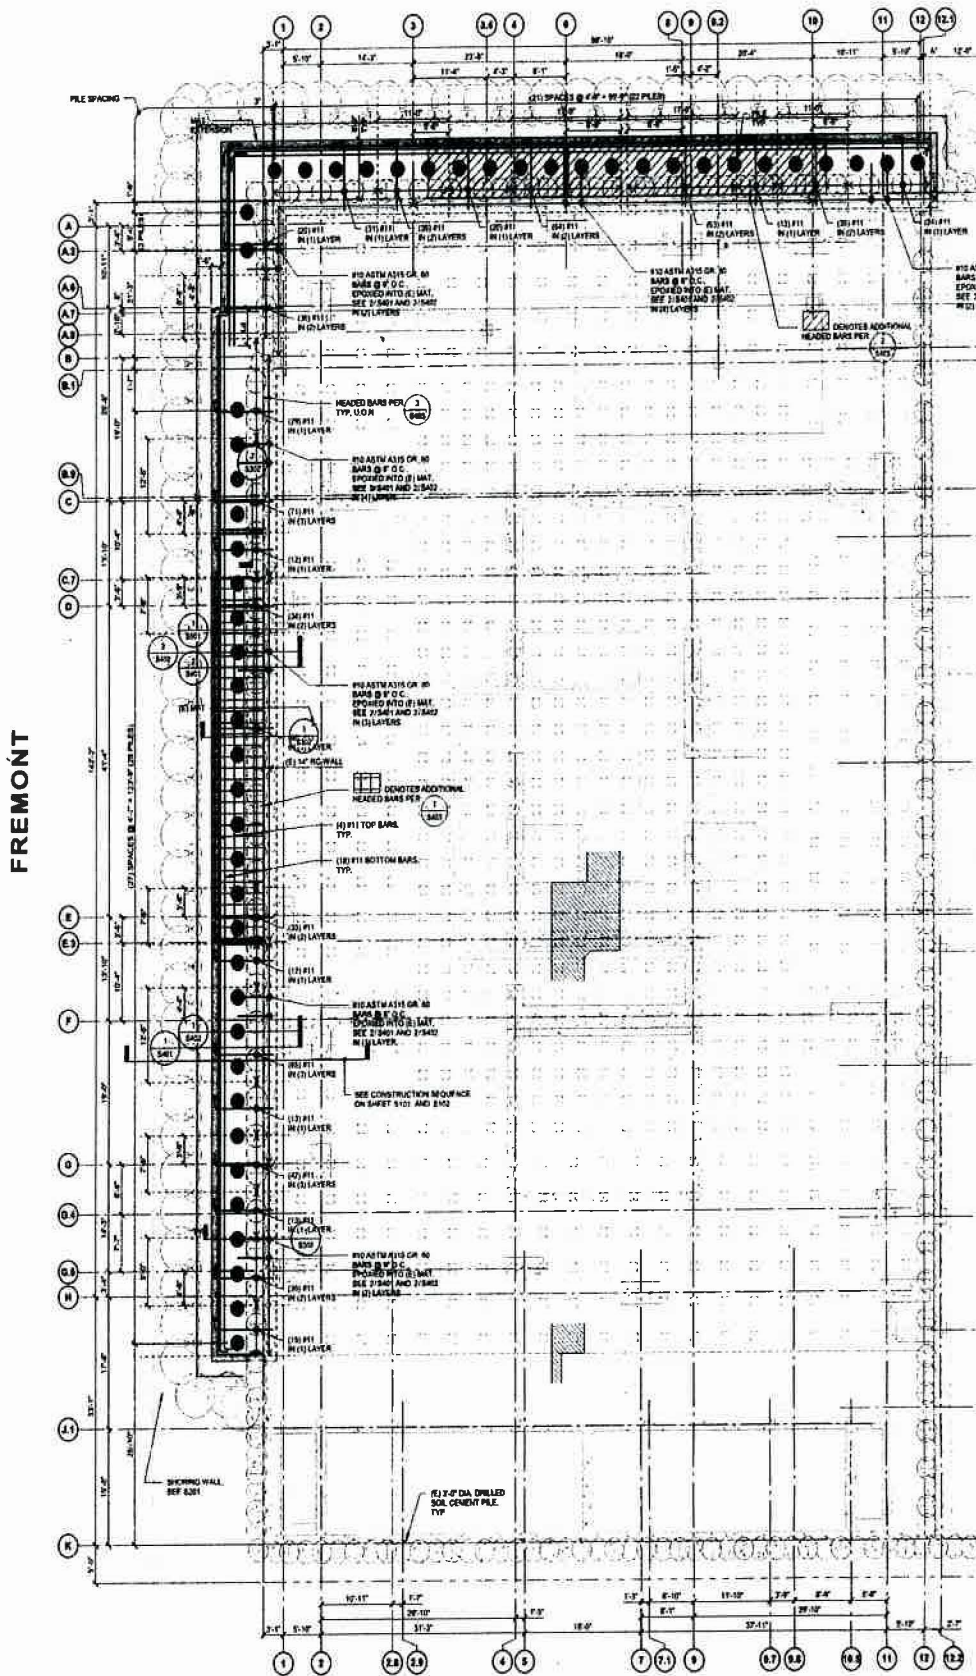
EXTERNAL ASYMMETRICAL FOUNDATION PLAN

The external plan (attached schematic), designed by Simpson Gumpertz & Heger (SGH) Consulting Engineers has a total of 52 drilled and cased very closely spaced piles along Mission and Fremont Streets; 30 along Fremont and 22 along Mission that are connected by a continuous concrete pile cap that will be doweled into the existing substructure so the new piles will provide bedrock support, which will be eccentric, for about one-fifth of the building's total load.

An SPTC wall 47 feet deep will be built to shore a 27 foot deep, 10 foot wide excavations in both streets between the shoring and the existing substructure. A 5 foot thick grout plug will be constructed at the bottom of the excavation to prop the shoring at excavation subgrade, restrict backslope subsidence and basal heave, and provide an area to work in the dry. Piles will be drilled from the street and cased from bedrock to the level of the mat's bottom.

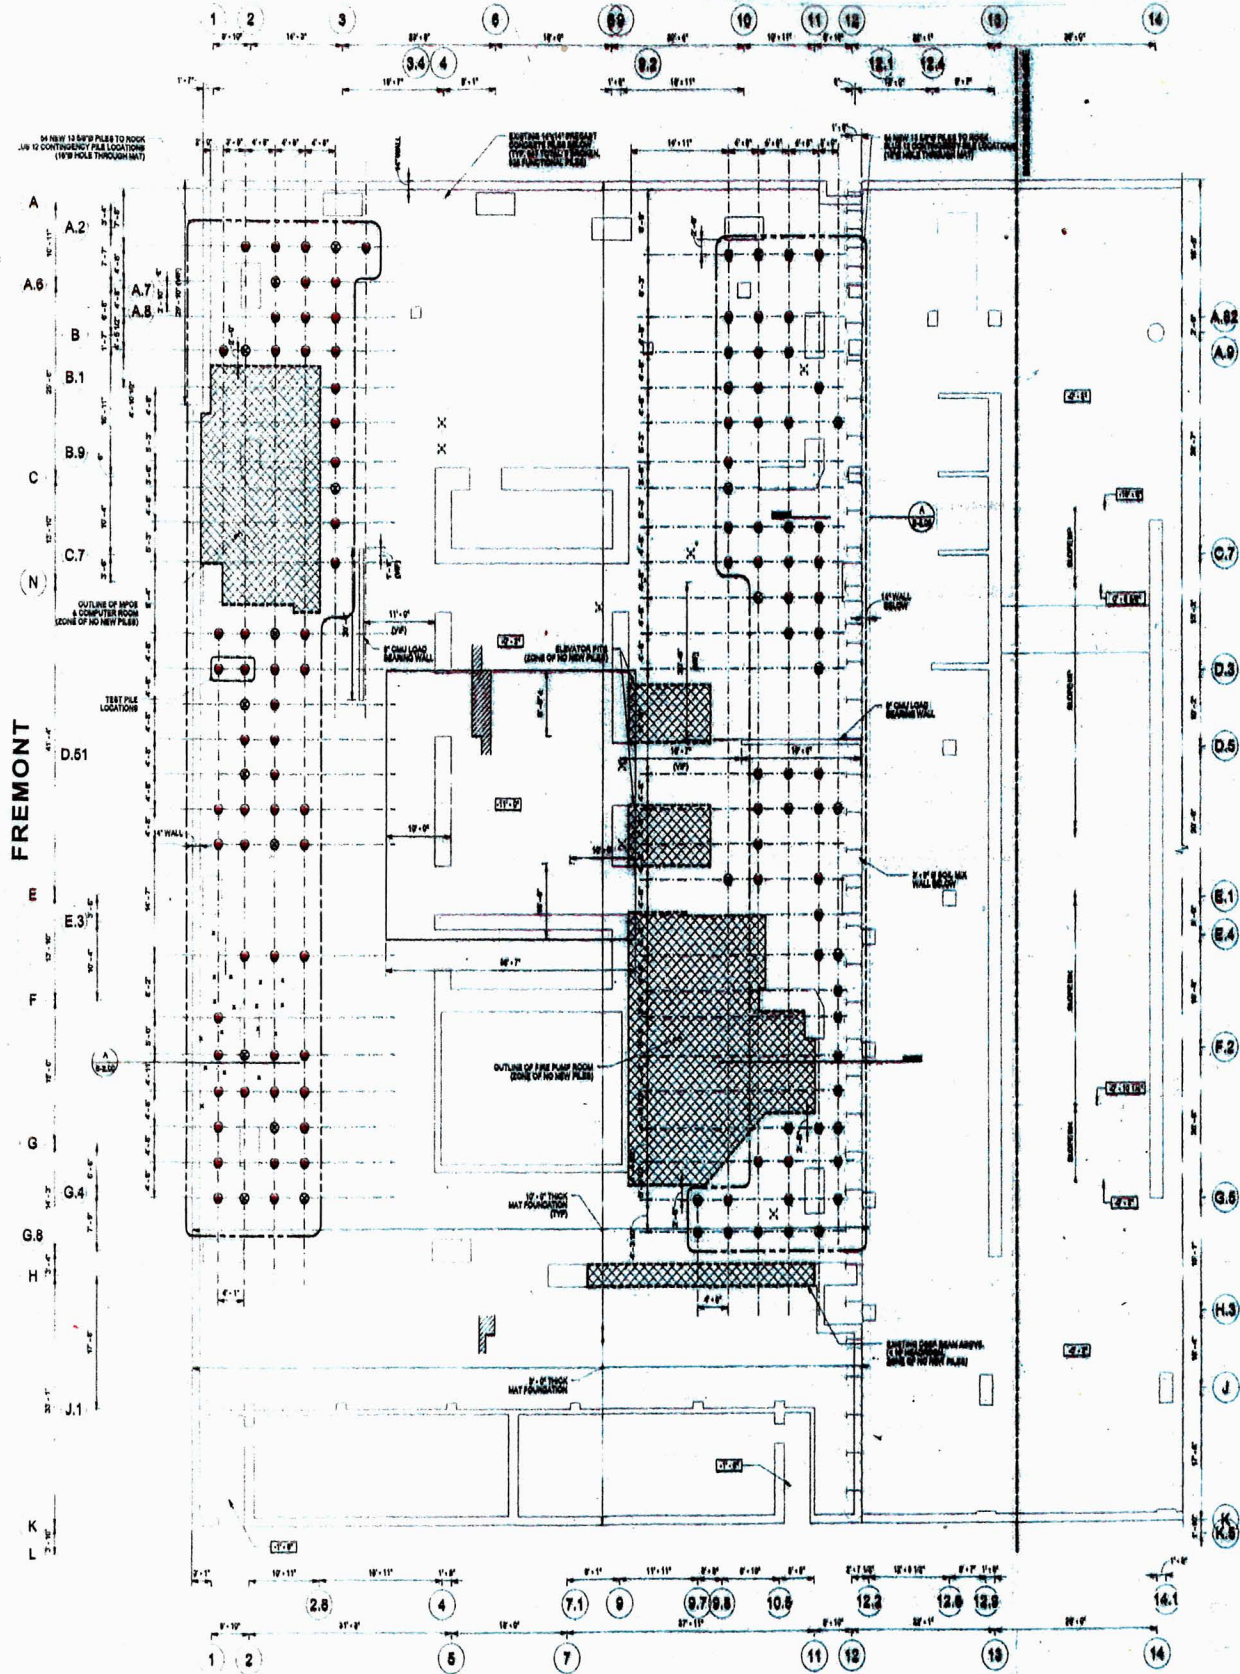
INTERNAL SYMMETRICAL FOUNDATION PLAN

The internal plan (attached schematic), designed by Leslie E. Robertson Associates (LERA), Consulting Structural Engineers, designer of the World Trade Center in New York, has a total of 108 new steel jacketed piles, 54 on the Fremont side and 54 on the opposite side of the building, arranged in a symmetrical longitudinal and transverse pattern that are installed inside the basement and will perform entirely within the building's footprint. The upper portions of the 13-5/8 inch outside diameter 5/8 inch wall thickness steel rock piles are 30 feet long in and below the existing concrete mat, and inside the larger pipes are 9-5/8 inch outside diameter 1-3/8 inch wall thickness steel rock piles. The smaller piles extend through the larger piles into bedrock that is projected to be 220 feet from the bottom of the Millennium Tower mat portion of the substructure.

The entirely new pile system will provide full uniform and symmetrical vertical and lateral support for the Tower. The new lateral resistance to base shear provided by the 108 13-5/8 inch diameter piles below the mat is a much improved lateral force resisting system over the original design that relied on passive resistance against the basement wall and the prestressed concrete piles with the design assumption that the bottom of the mat substructure would remain level.

The new piles will be jacked into bedrock through holes cut through the basement slab. The jacking system uses the weight of the concrete building as a reaction. Pile locations as finally set were arranged to avoid MPE utilities, computer facilities, and fire pump house. Pile sections have threaded connections, there is no welding and annular space in the piles are grouted. The internal plan does not involve any dewatering and there is no drilling through soils. There is potential with the internal plan to at least partially return the substructure to a more level condition during the jacking process.
