Date: October 13, 2021
Project Number: 19-009
Subject: 301 Mission Retrofit Monitoring Report 024: Results as of October 12, 2021

Millennium Tower Perimeter Pile Upgrade: Instrumentation Monitoring Data City and County of San Francisco, California

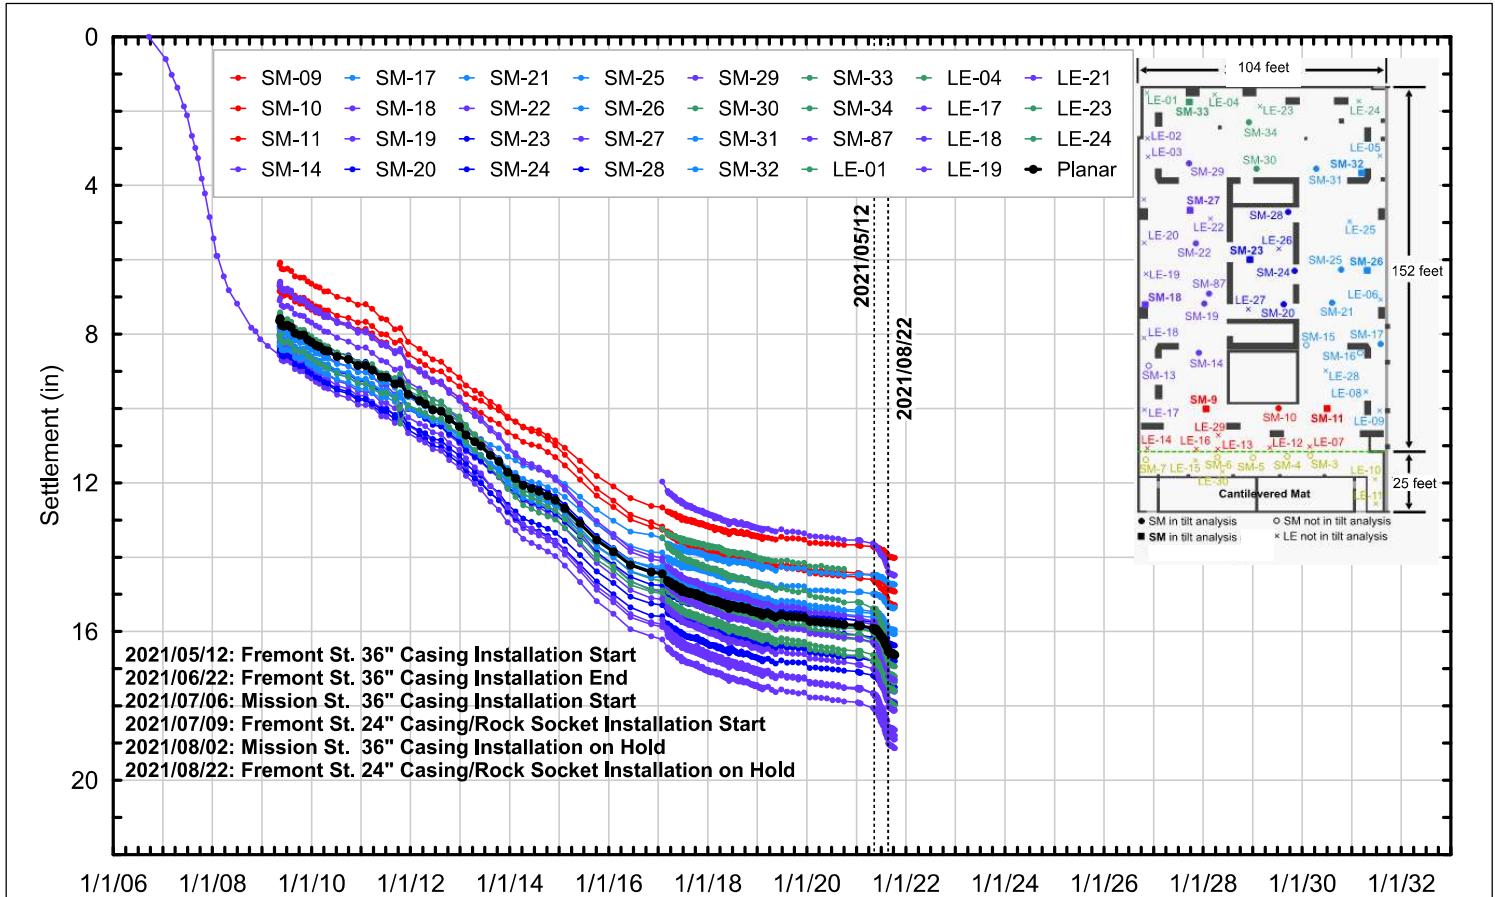
Project No: 19-009.00	Date: 10/13/2021	Created By: NBW	Checked By: DGM	Figure No: 024-02

Figure 02 presents the historical settlement data interpreted from settlement markers installed on the B-1 Level of 301 Mission Tower. In addition, data from surveys performed during the retrofit are included. Figure 03A presents settlement data since the start of production pile installation (May 12, 2021; baseline readings on May 10, 2021) through October 11, 2021. Figure 03B presents settlement data since January 11, 2021, through October 11, 2021. Figure 04 presents current settlement contours (in inches) on October 11, 2021.

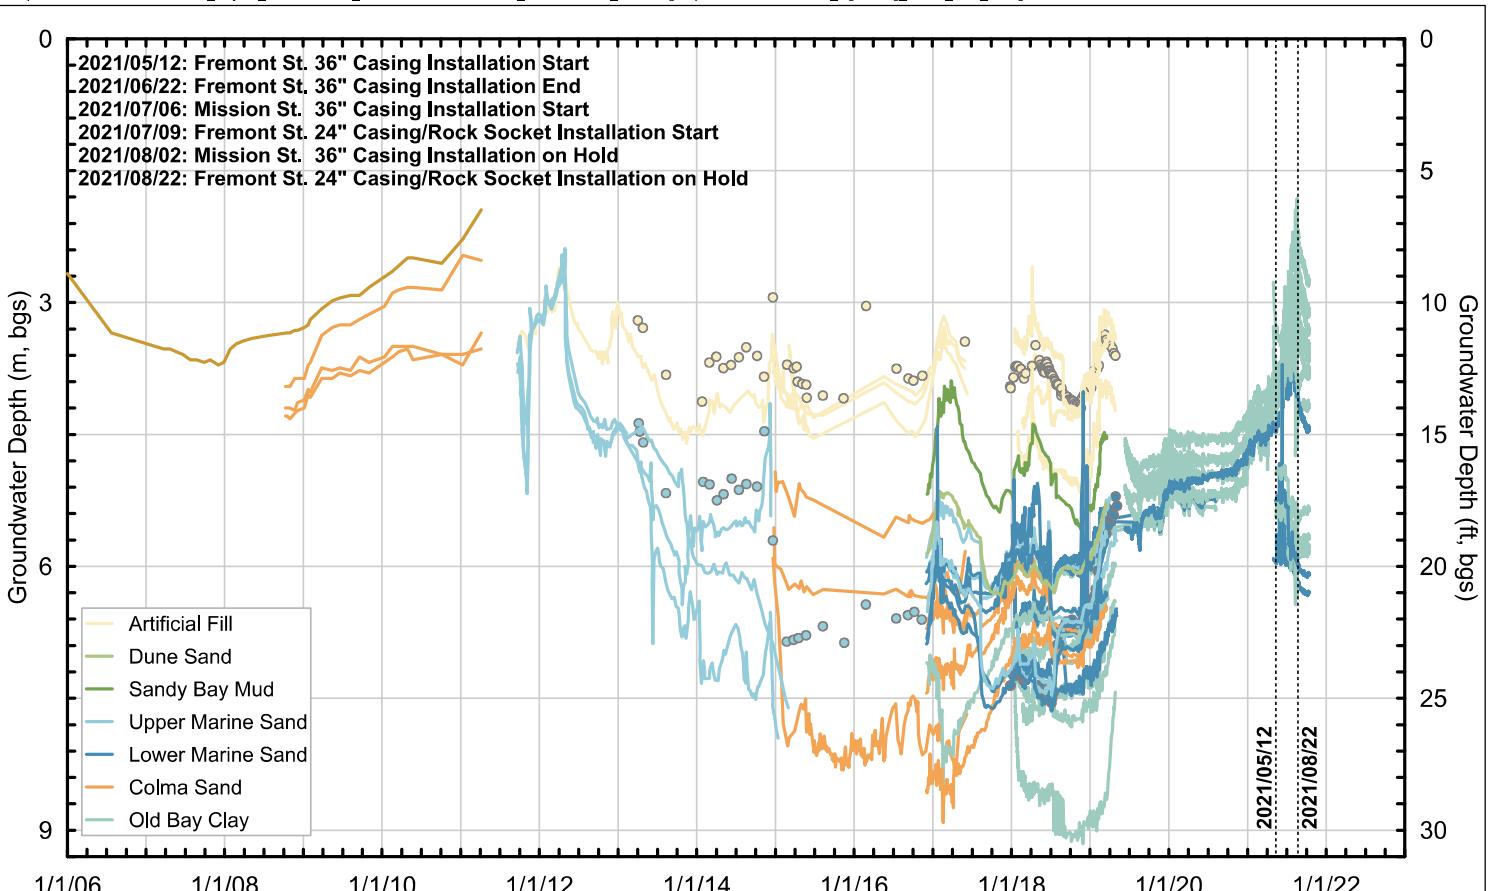
Project No: 19-009.00	Date: 10/13/2021	Created By: NBW	Checked By: DGM	Figure No: 024-07

Figure 07 presents the historical groundwater elevation interpreted from piezometer readings at locations near 301 Mission. In addition, data from piezometers installed to monitor groundwater elevation during the retrofit are included. Figures 08 and 09 present groundwater elevation interpreted from piezometer readings in the Marine/Colma Sand and the Old Bay Clay, respectively, for the time period prior to the start of production pile installation (January 1, 2021) through October 12, 2021.

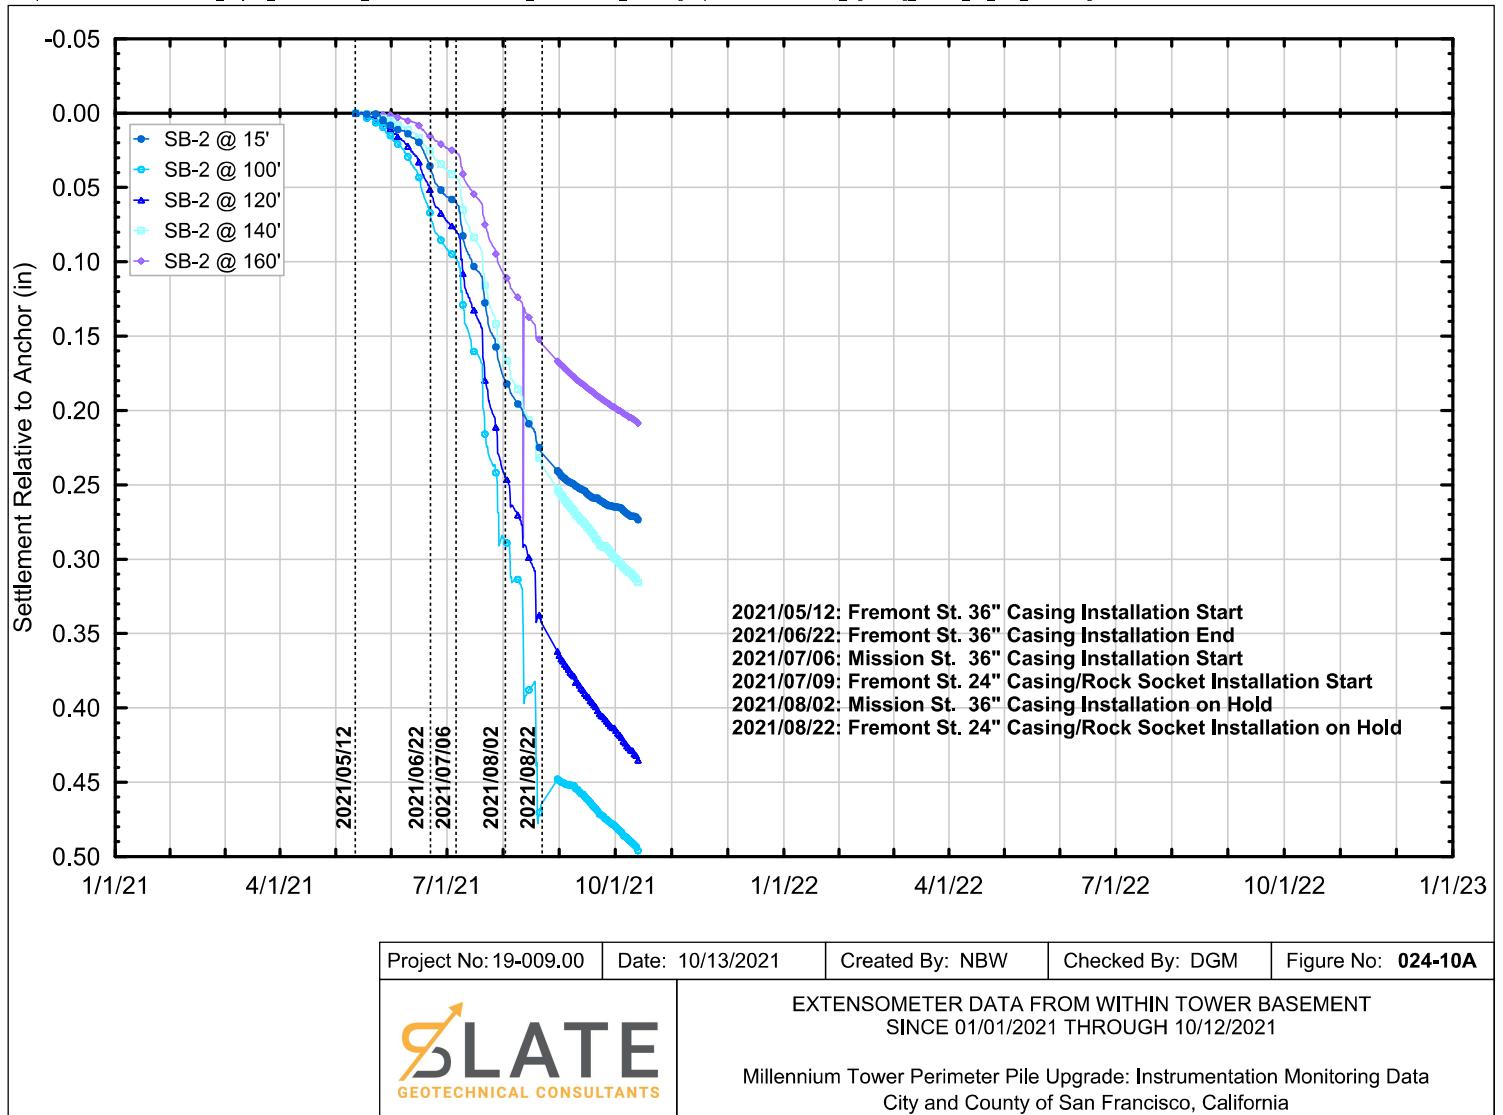
Filepath: S:\SlateDrive - Documents\Projects_2019\19-009.00_Millennium Tower Retrofit\10_Construction\01_Monitoring Reports\TowerSoilWater\00_Figures\Fig_024-10A_Ext_Data_Basement.grf

Figure 10 presents extensometer data from within the Tower basement since the start of production pile installation (May 12, 2021) through October 12, 2021. Figure 11 presents extensometer data from Fremont

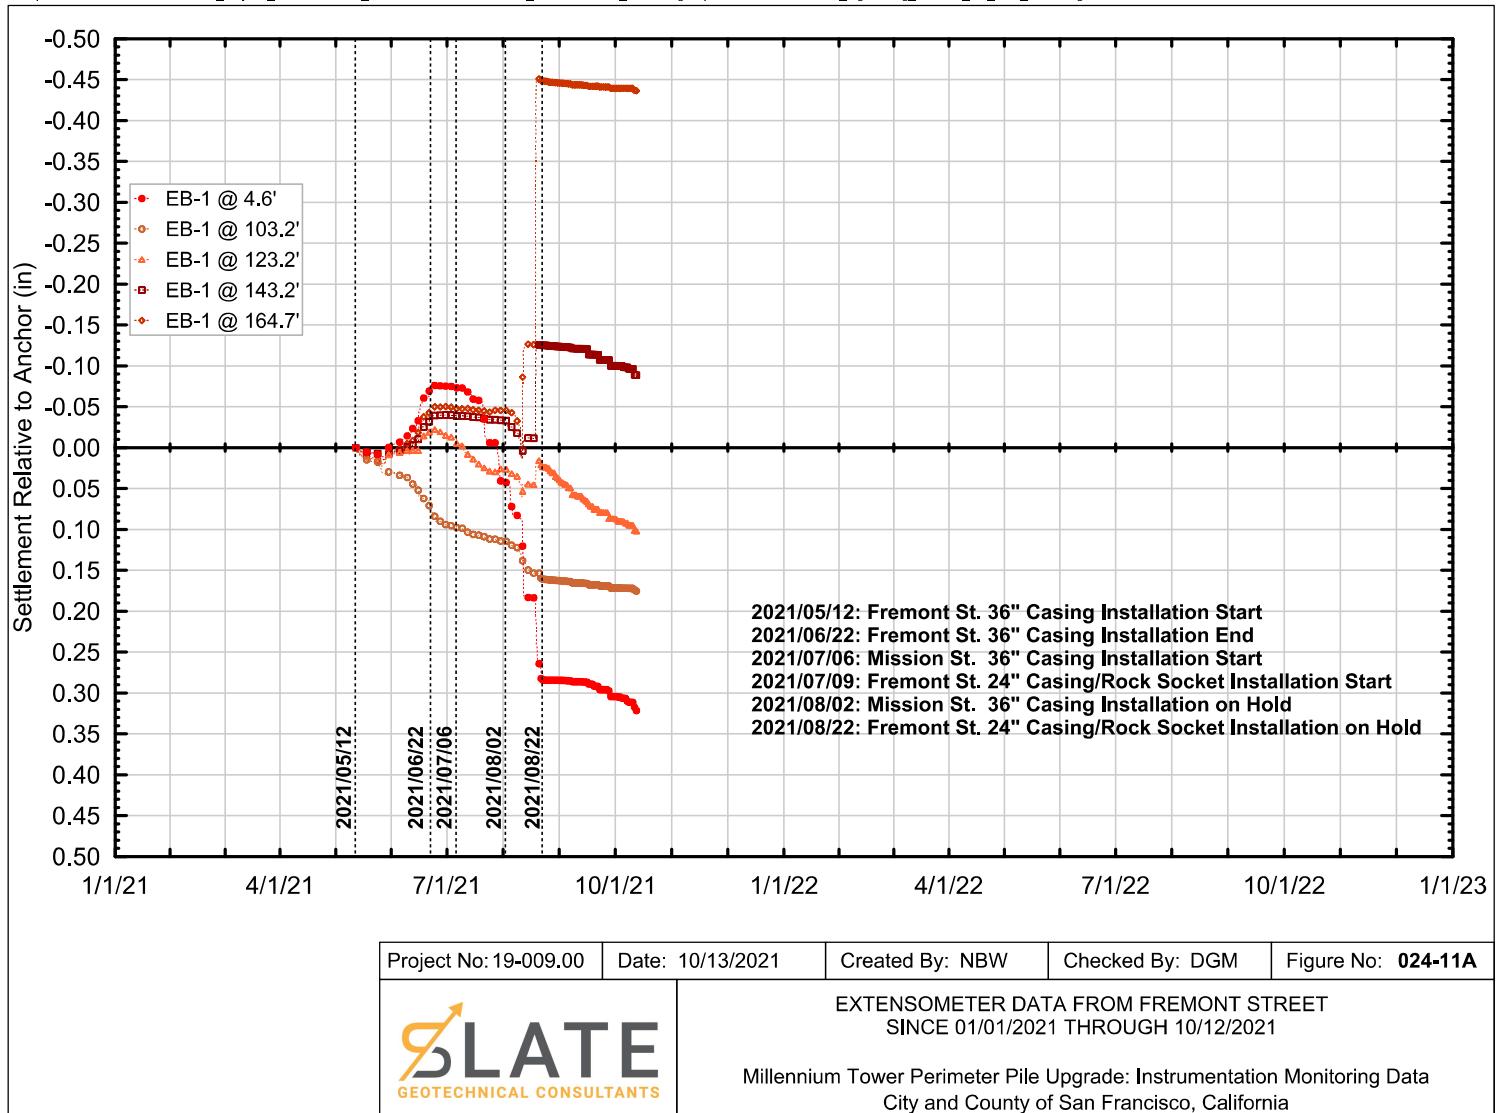
Filepath: S:\SlateDrive - Documents\Projects_2019\19-009.00_Millennium Tower Retrofit\10_Construction\01_Monitoring Reports\TowerSoilWater\00_Figures\Fig_024-11A_Ext_Data_Fremont.grf

Street since the start of production pile installation (May 12, 2021) through October 12, 2021. Figure 12 presents extensometer data from Mission Street since the start of production pile installation (May 12, 2021) through October 12, 2021.
