# Transbay Transit Center Project Shoring Wall and Excavation Construction

June 8, 2010

- Subsurface conditions and Transit Centre box
- Excavation process
- Movement analyses
- Movement monitoring
- Summary

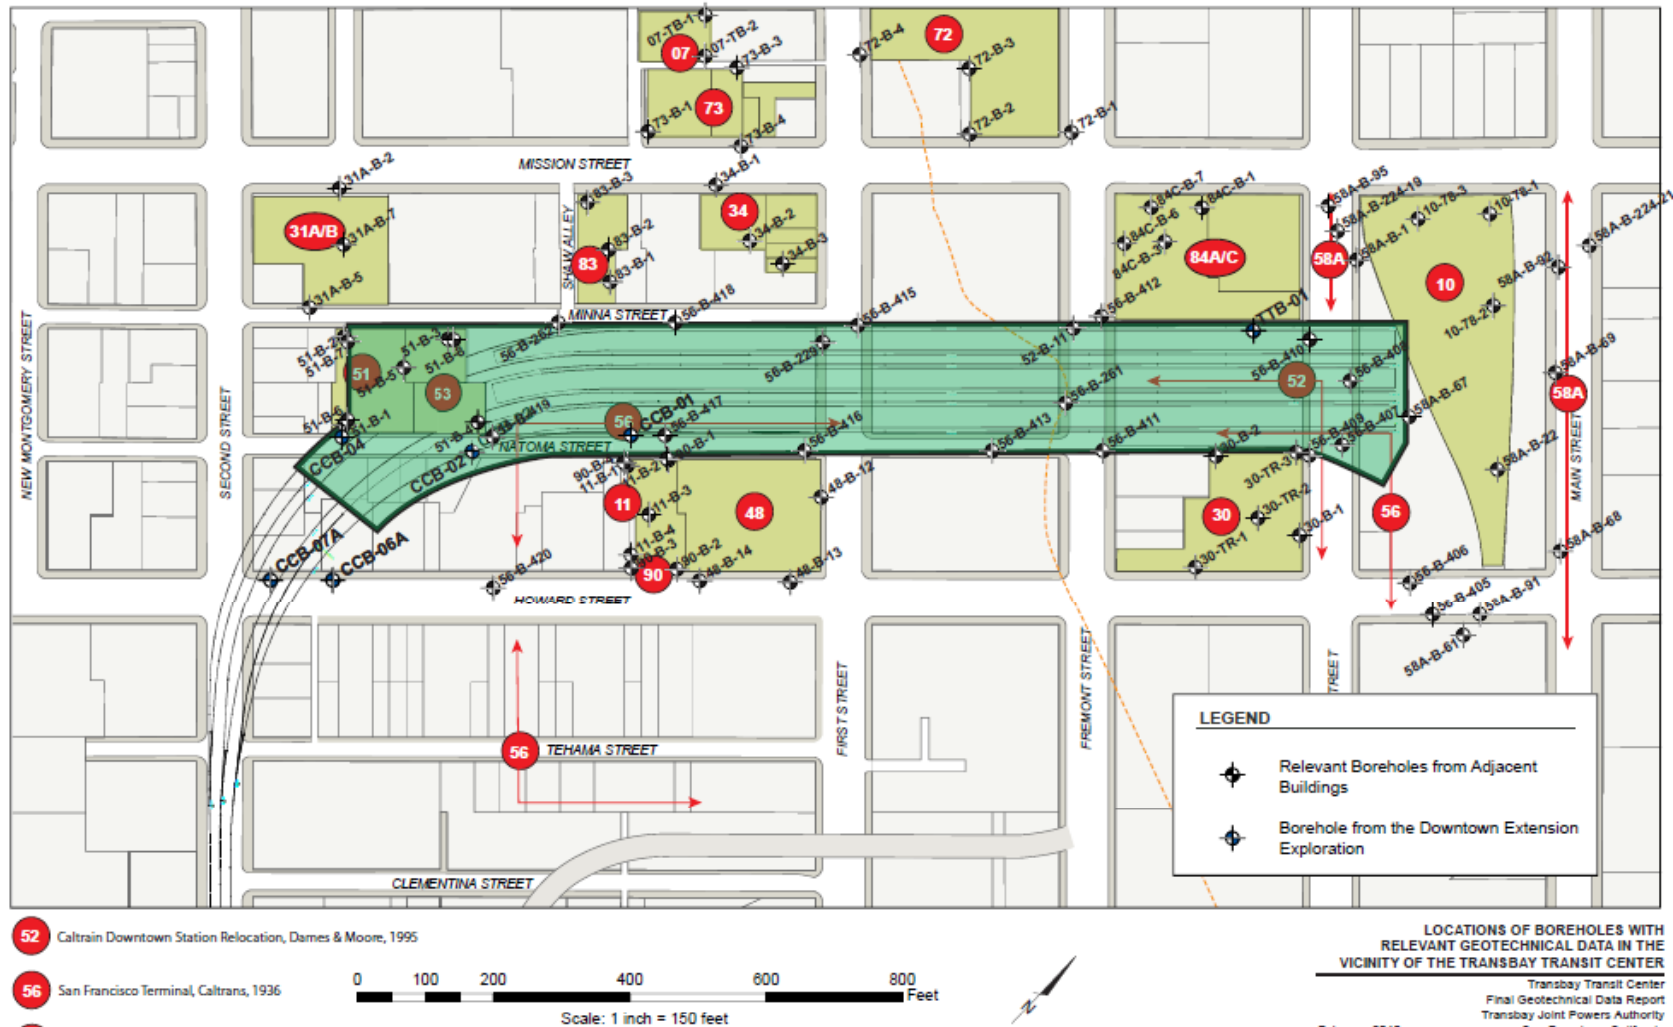
PLATE 4

# Borehole Locations and Adjacent 3<sup>rd</sup> Party Geotechnical Data

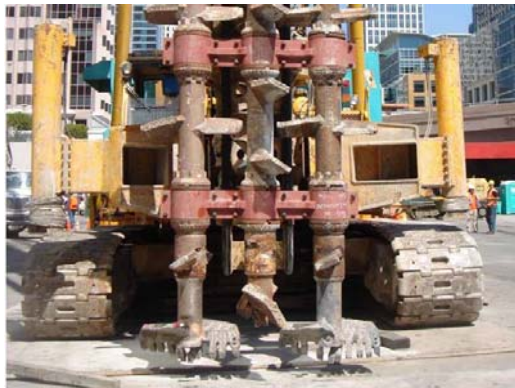
# Soil-Cement Walls – Sequence of Installation

## 1) Mixing of First Primary Panel

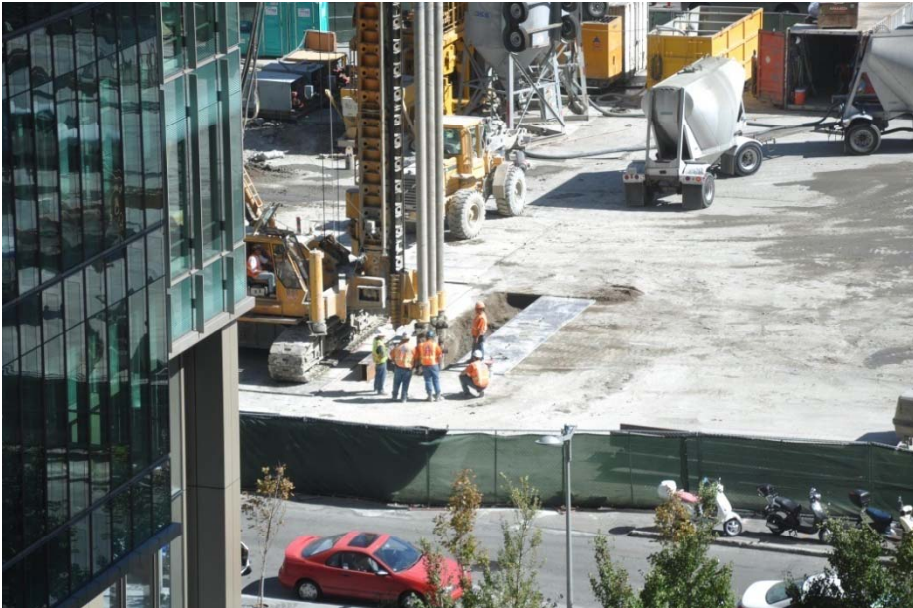
## DMM Rig during constructability trials

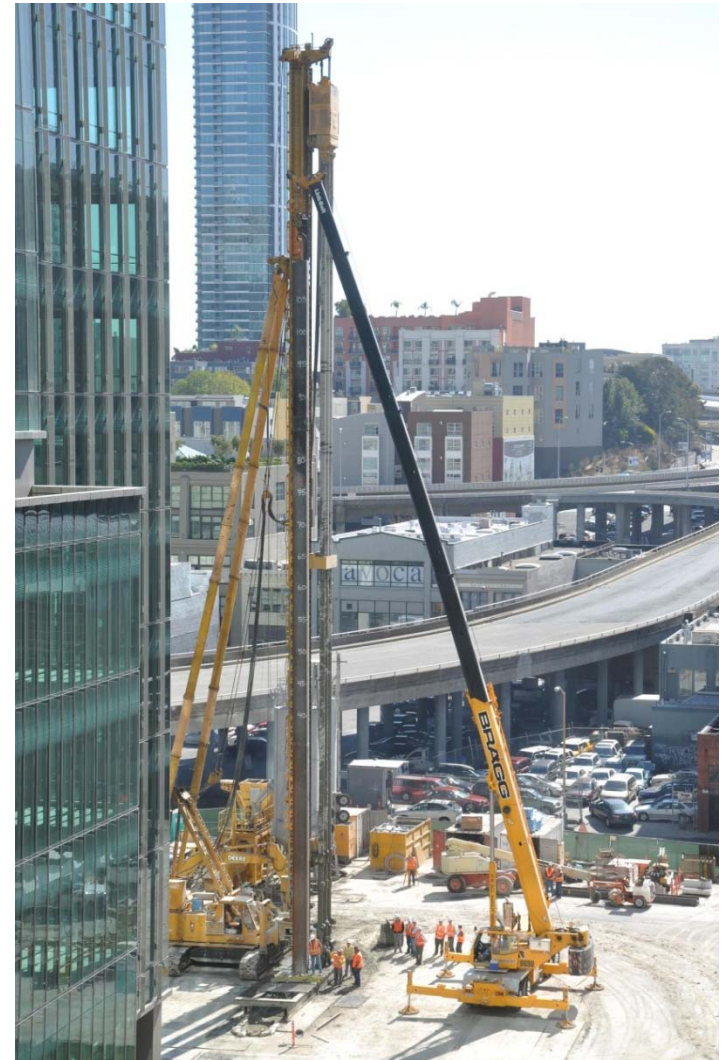
## Installation of Beam

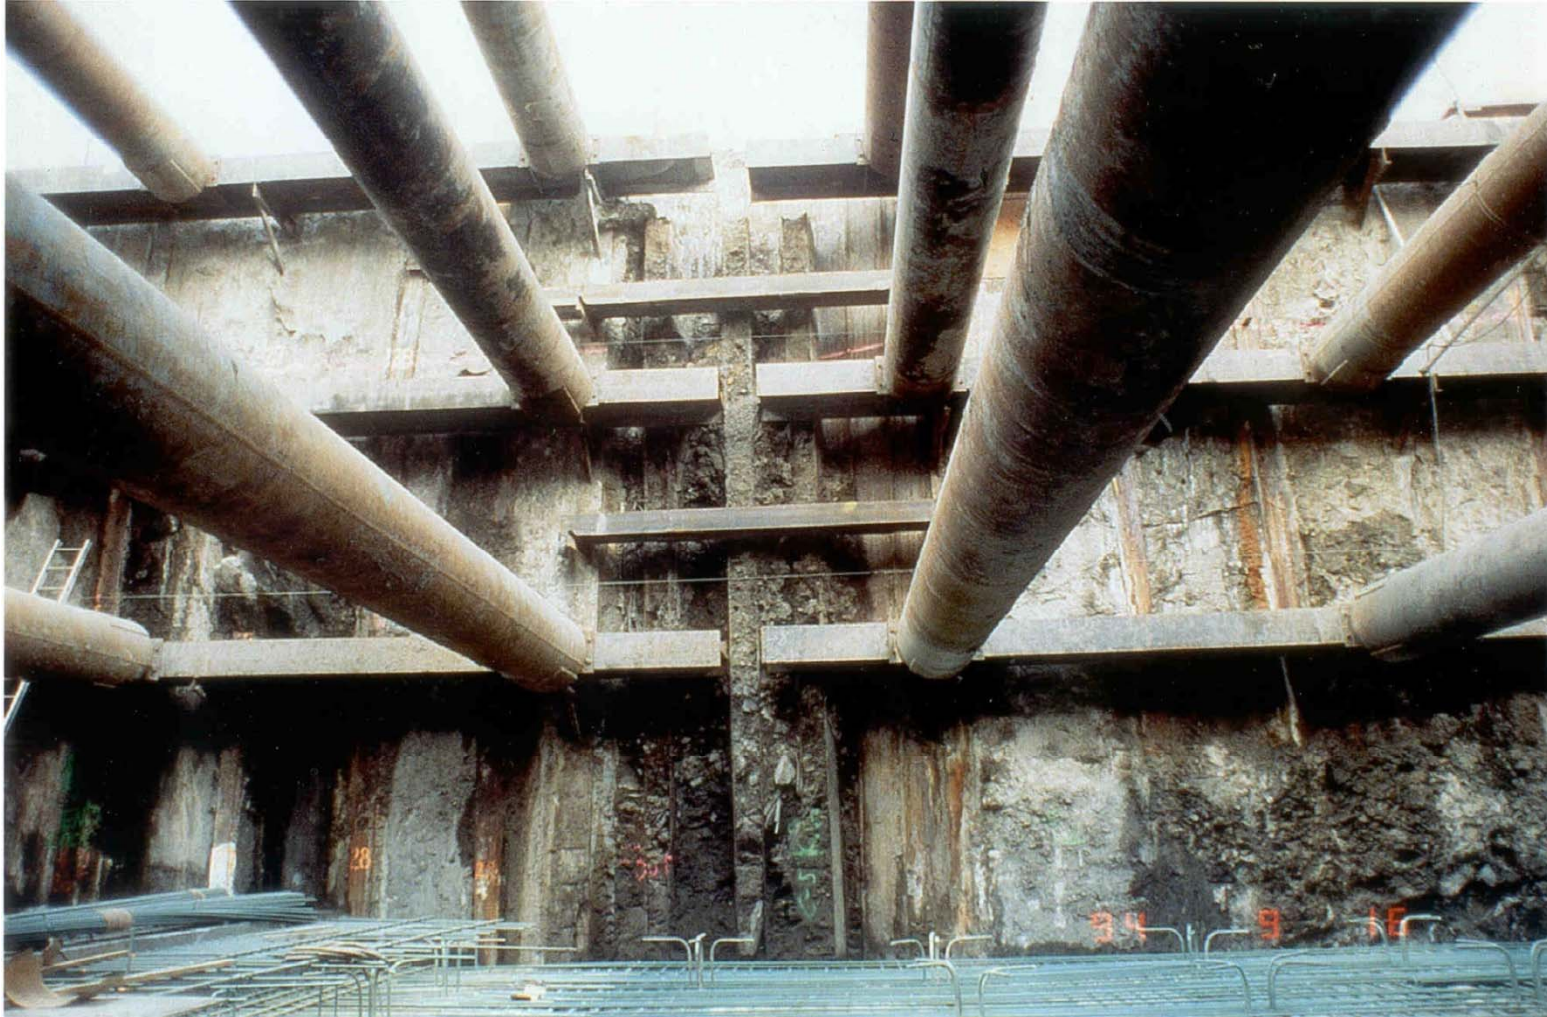
# Typical Cross Lot Bracing Deep Excavation Along The Embarcadero Muni Metro Turnback Project

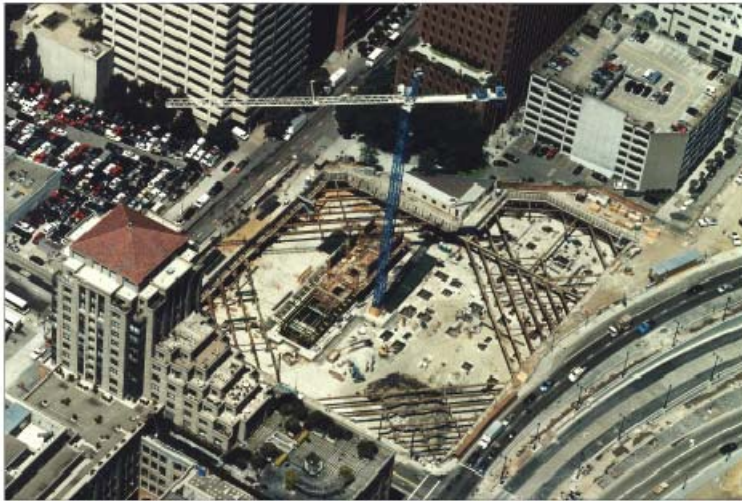
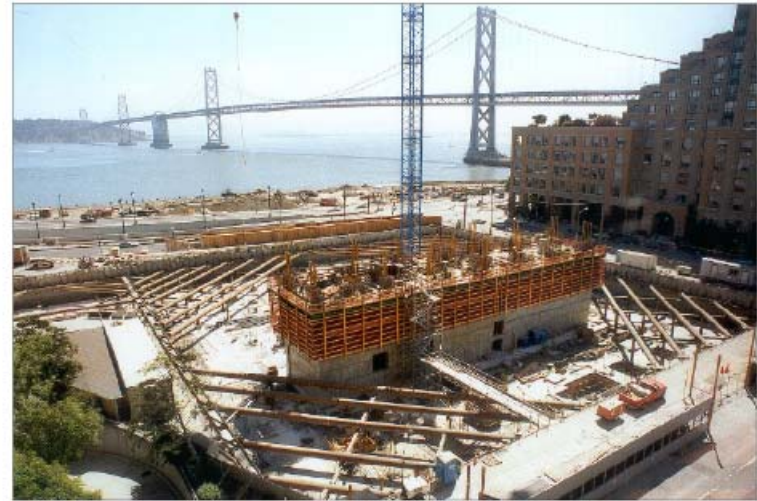
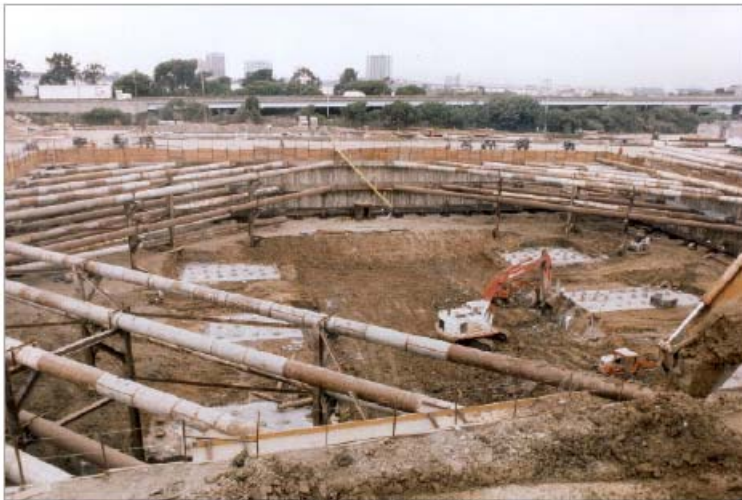
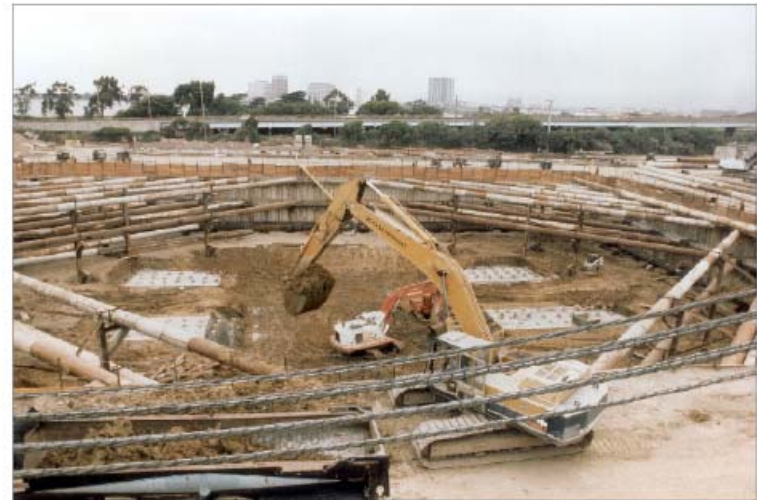
# Typical Diagonal Bracing of Deep Excavations Gap Building and EBMUD Wet Weather Building

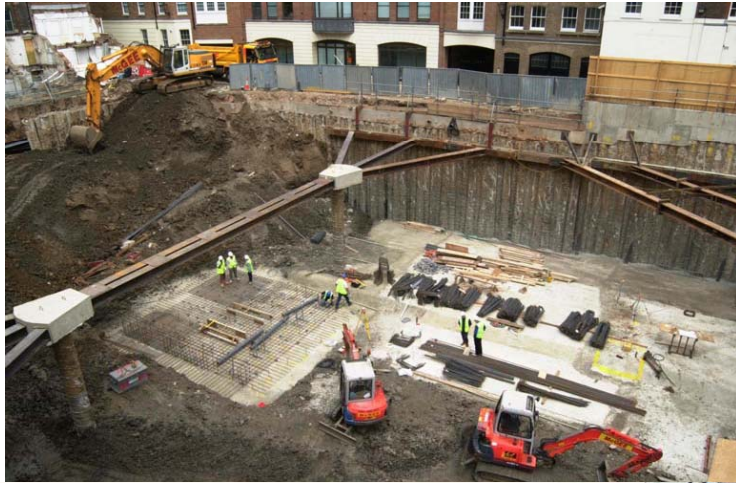
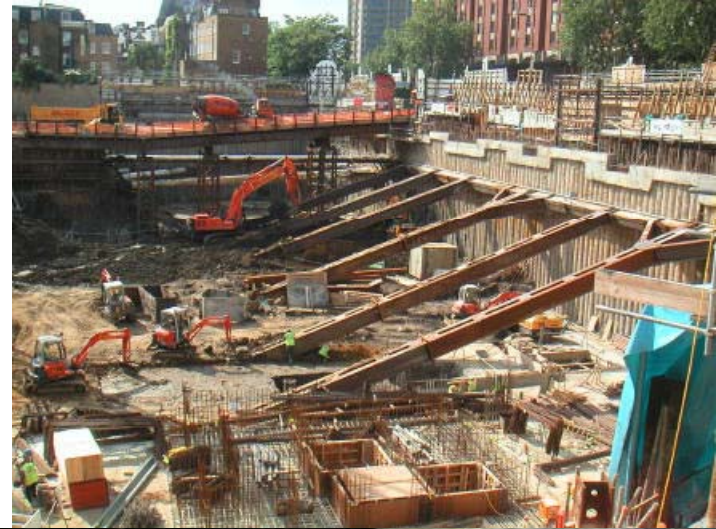
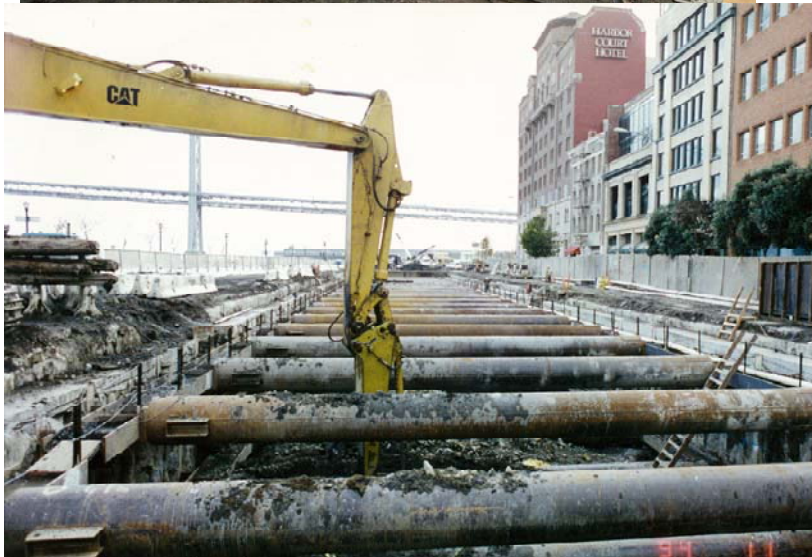
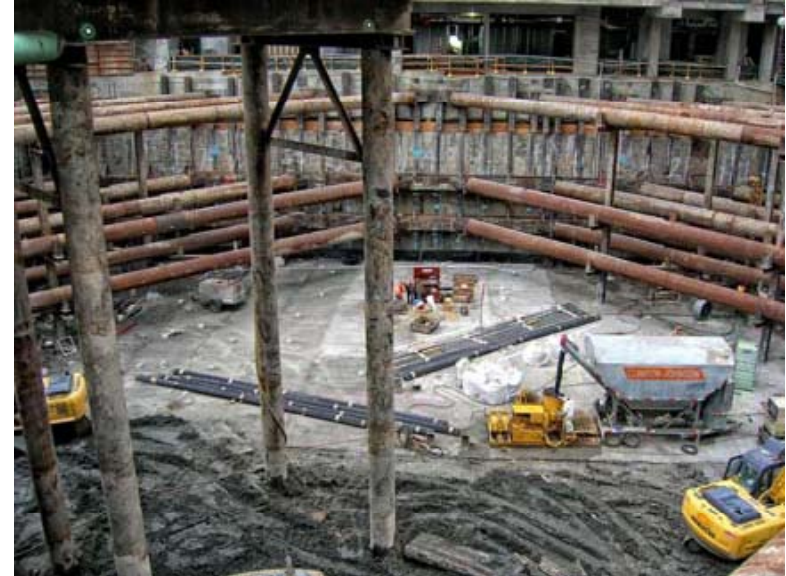
## Many ways of providing internal support to deep excavations

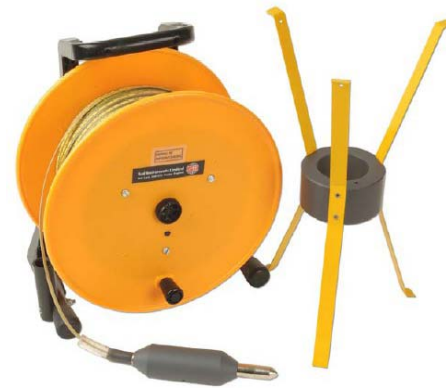
**Extensometer**

**Inclinometers and extensometers(sub surface displacements).**

**Can be real time or manual  
Inclinometer (x, y, 0.002 in/ft)  
Extensometer (z, +/- 0.01 inch)**

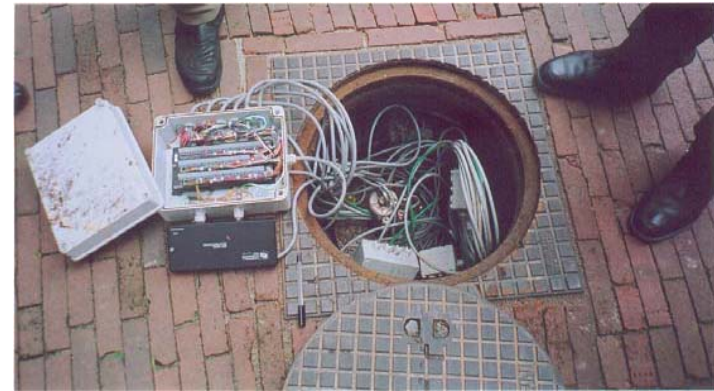
**Real time extensometer & inclinometer installation**

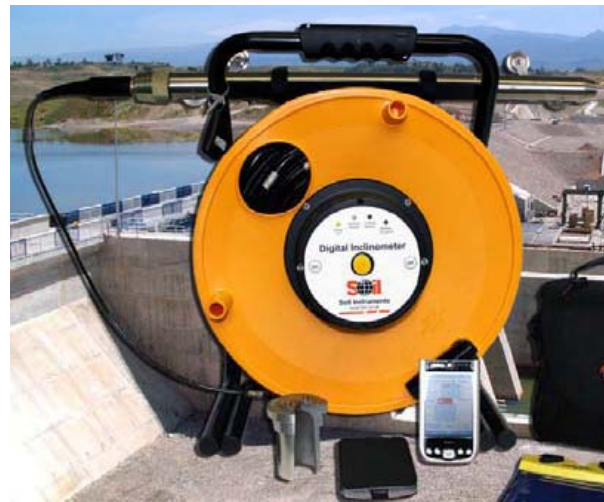
**Inclinometer and logging device**

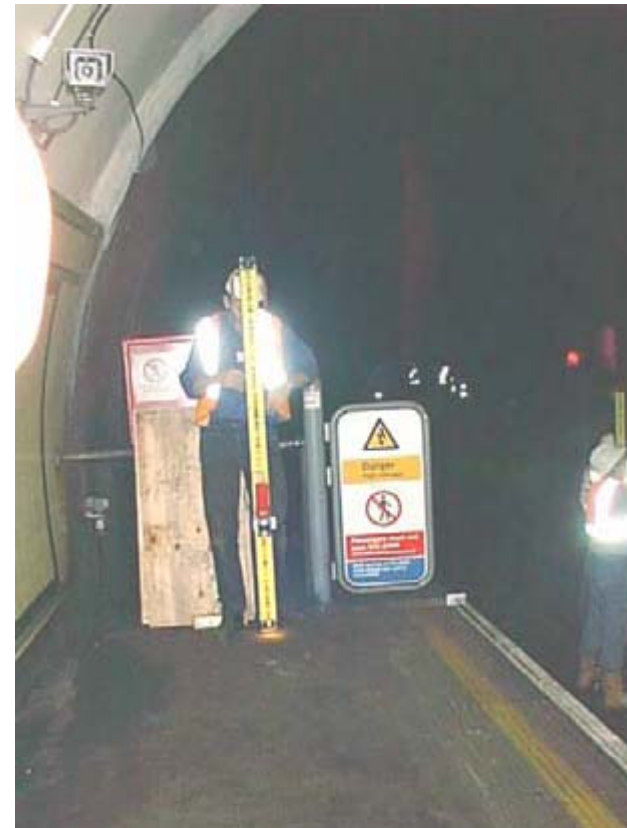
# Deep settlement marker and levelling points
