RESIDENCE for MR. & MRS. SANFORD AUTUMN  
521 SAUSALITO BOULEVARD SAUSALITO, CALIFORNIA  
VIOLETA AUTUMN-ARCHITECT  
2115 TARAVAL ST. SAN FRANCISCO 10, CALIF. LO 4-G752  
HALUK AKOL • STRUCTURAL ENGINEER  
2171 SHATTUCK • BERKELEY • CALIF. • TH 3-D432 H.E.  
REVISIONS DATE SHEET NO.  
**3**

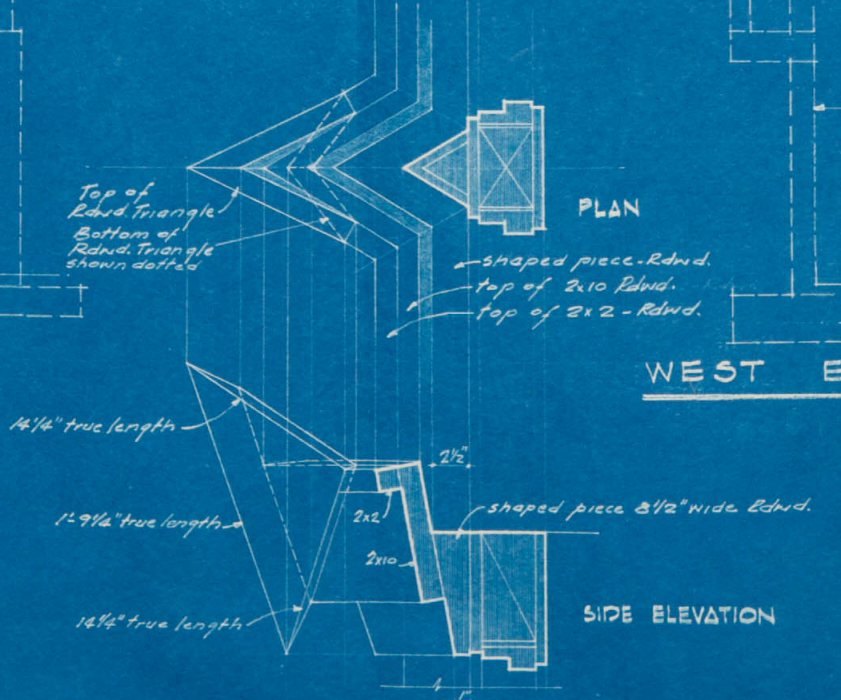
**SIDE ELEVATION**

**DETAIL of TRIANGULAR ROOF ORNAMENTS**  $\frac{1}{2}" = 1'-0"$
