Date: March 16, 2022
Project Number: 19-009
Subject: 301 Mission Retrofit Monitoring Report 045: Results as of March 15, 2022

Millennium Tower Perimeter Pile Upgrade: Instrumentation Monitoring Data
City and County of San Francisco, California

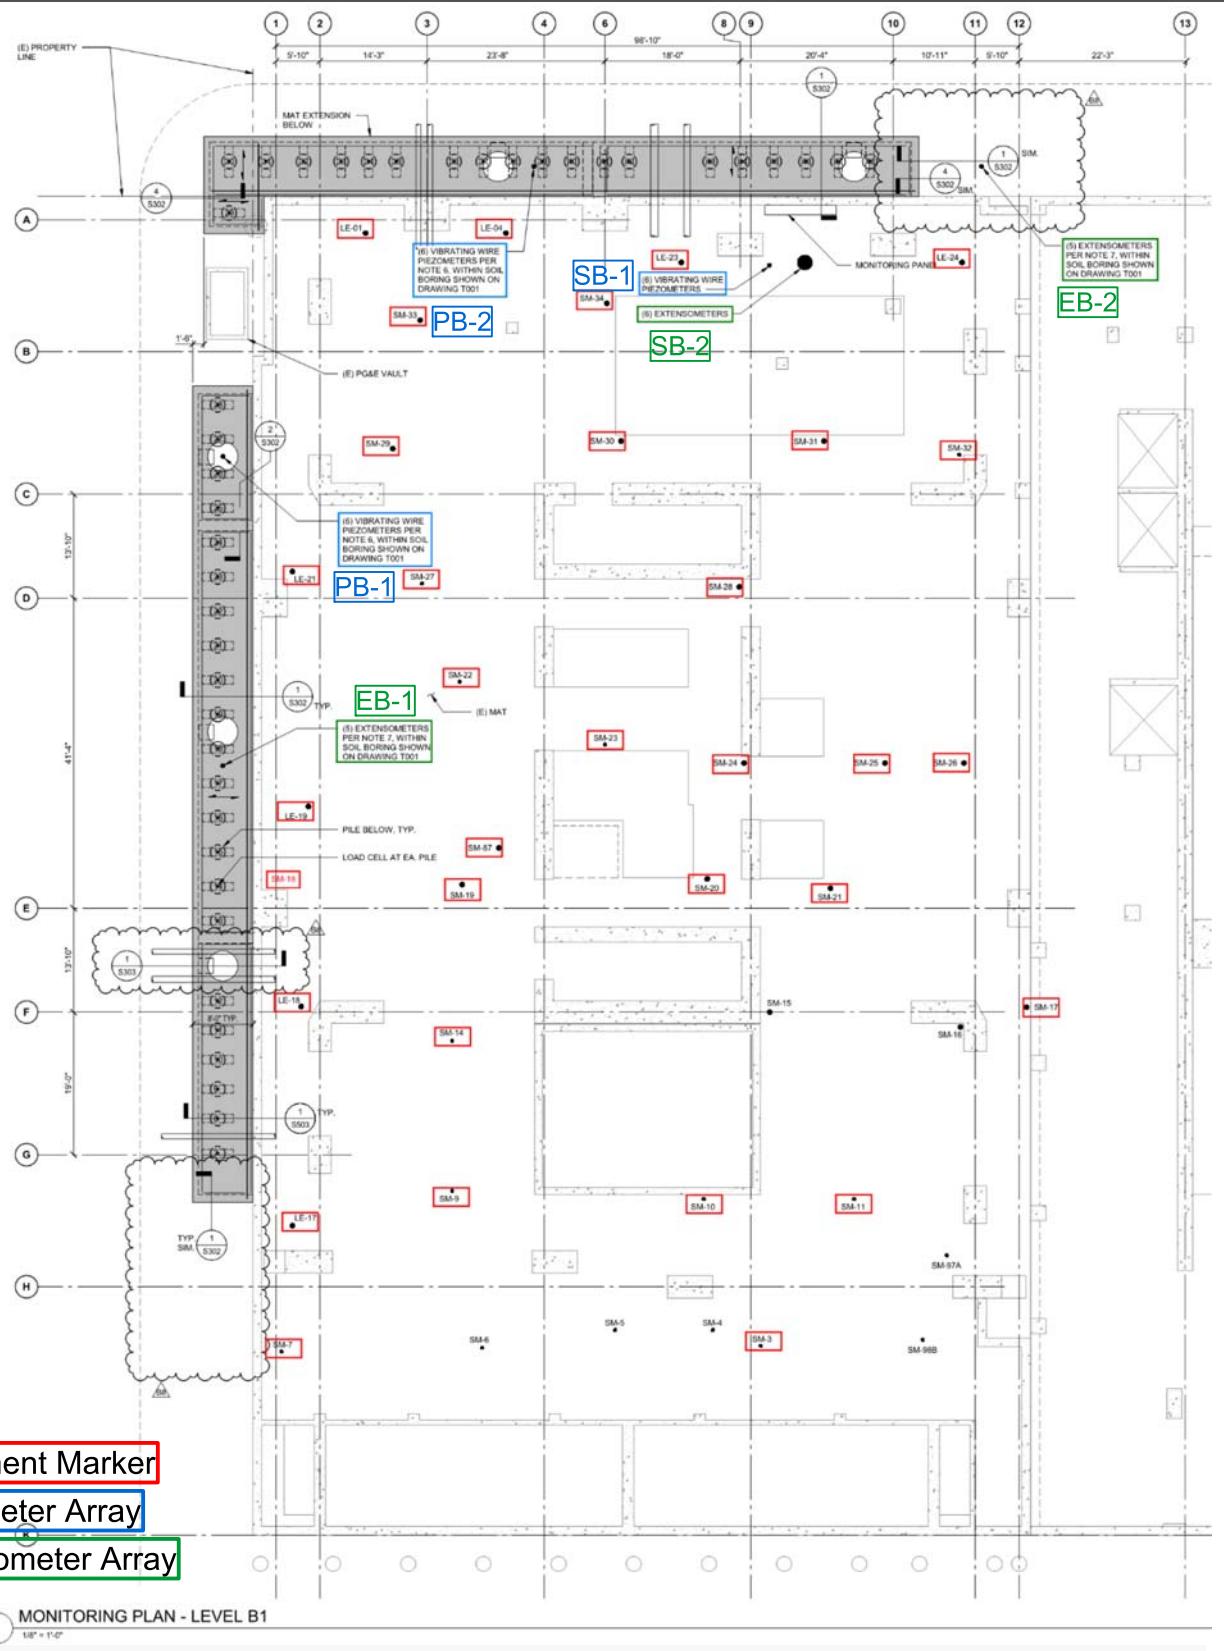
Project No: 19-009.00	Date: 7/26/2021	Created By: KAS	Checked By: DGM	Figure No: 045-01A
-----------------------	-----------------	-----------------	-----------------	--------------------

Figure 01 presents the instrument locations as referenced in later figures.

- Figure 01A – Instrument Location Map: Settlement Markers, Piezometers, Extensometers
- Figure 01B – Tower Survey Prism Location Schematic
- Figure 02 – Historical Settlement Marker Data

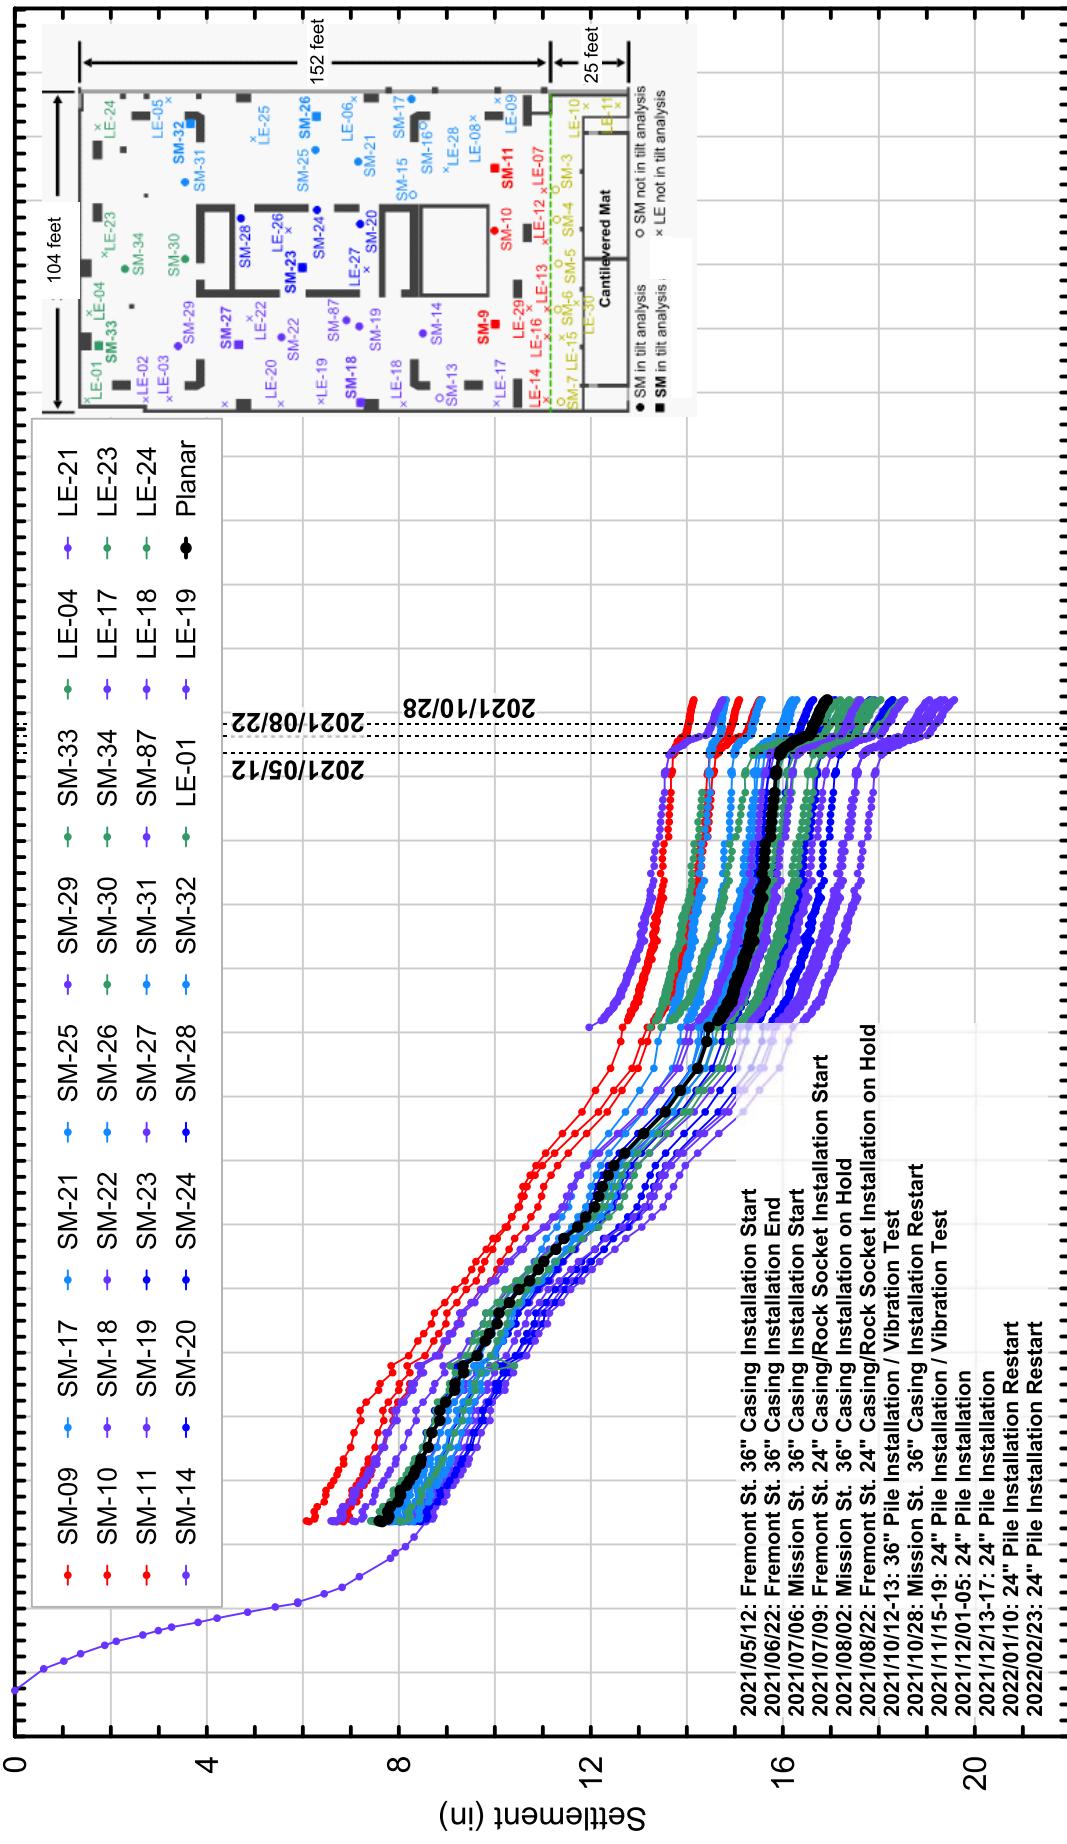
Project No: 19-009.00	Date: 3/16/2022	Created By: KAS	Checked By: DGM	Figure No: 045-02
-----------------------	-----------------	-----------------	-----------------	-------------------

Figure 02 presents the historical settlement data interpreted from settlement markers installed on the B-1 Level of 301 Mission Tower. In addition, data from surveys performed during the retrofit are included. Figure 03A presents settlement data since the start of production pile installation (May 12, 2021; baseline readings on May 10, 2021) through March 14, 2022. Figure 03B presents settlement data since January 11, 2021, through March 14, 2022. Figure 04 presents current settlement contours (in inches) on March 14, 2022.

HISTORICAL SETTLEMENT MARKER DATA

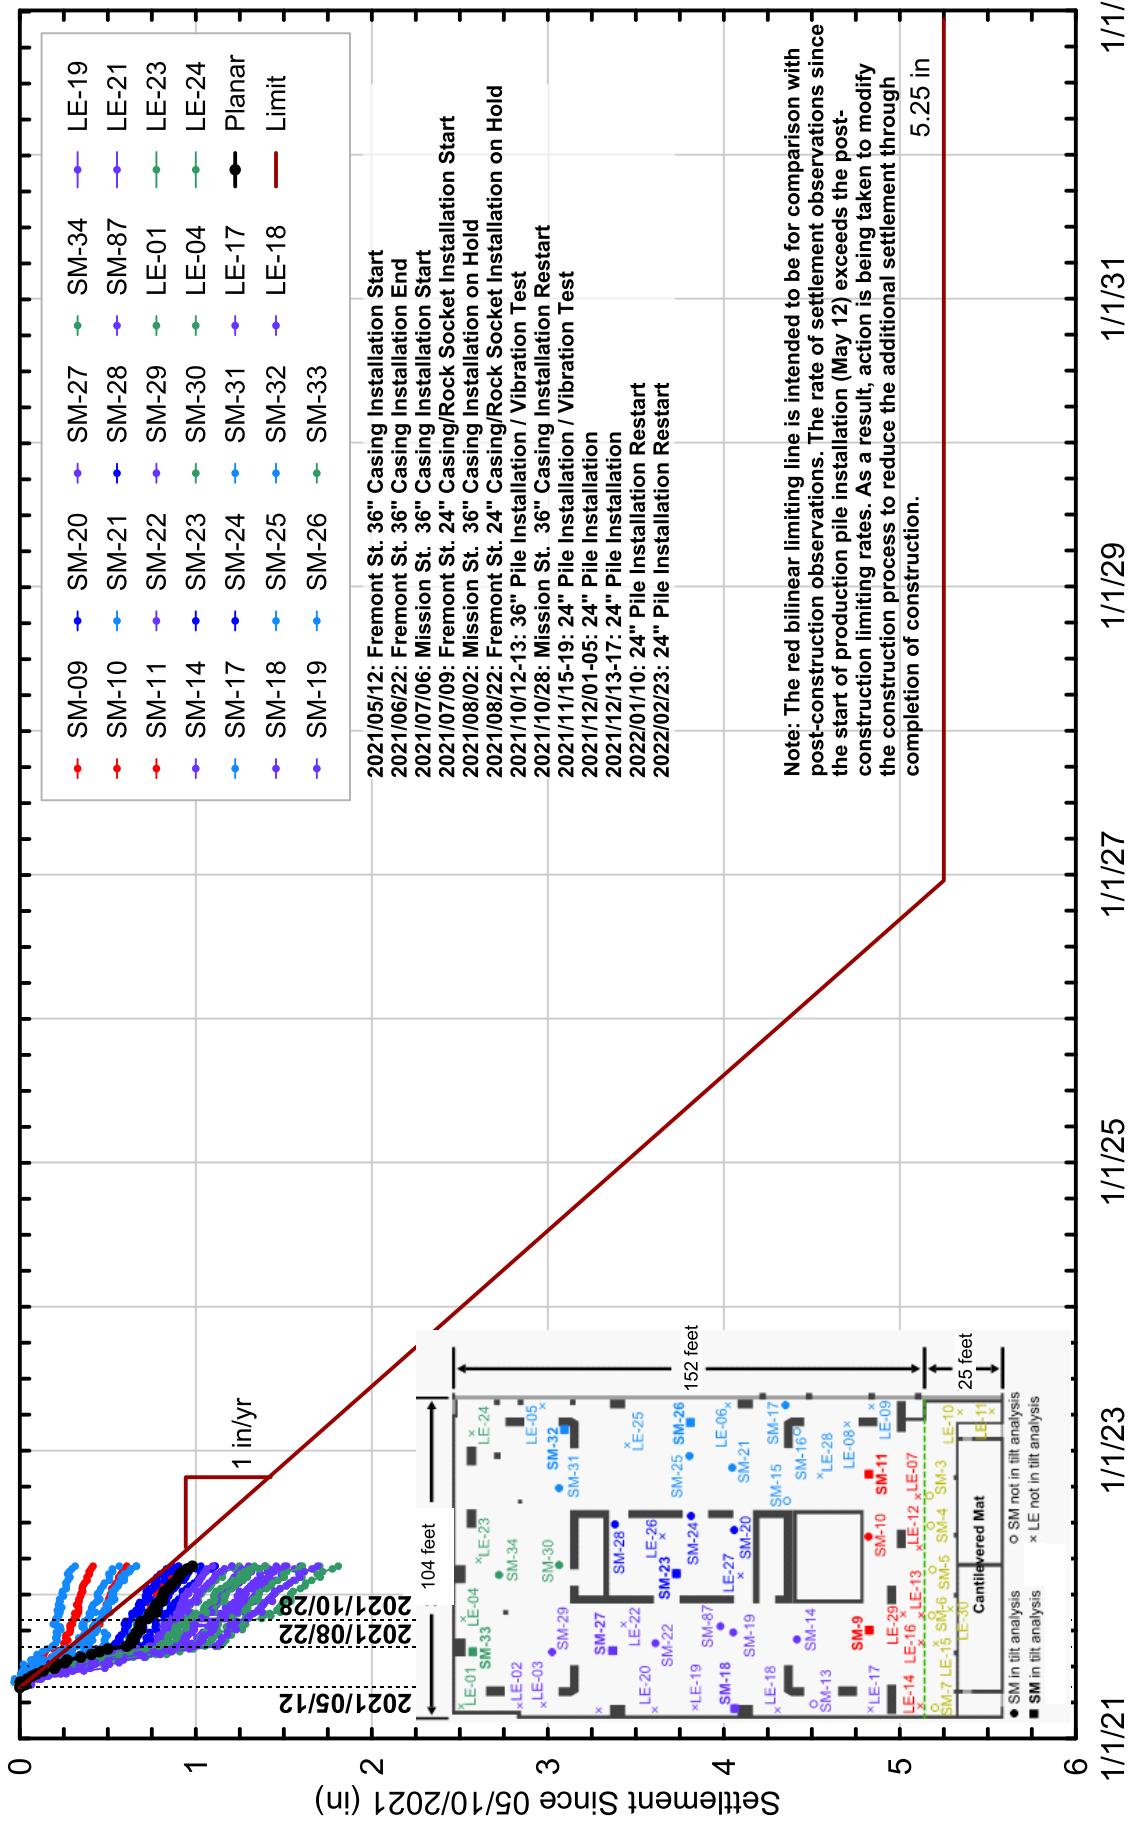
Project No: 19-009.00	Date: 3/16/2022	Created By: KAS	Checked By: DGM	Figure No: 045-03A
SETTLEMENT MARKER DATA SINCE 05/10/2021 THROUGH 03/14/2022 Millennium Tower Perimeter Pile Upgrade: Instrumentation Monitoring Data City and County of San Francisco, California

- Figure 03A – Settlement Marker Data since 05/10/2021 through 03/14/2022
- Figure 03B – Settlement Marker Data since 01/11/2021 through 03/14/2022
- Figure 04 – Settlement Contours since 05/10/2021 through 03/14/2022

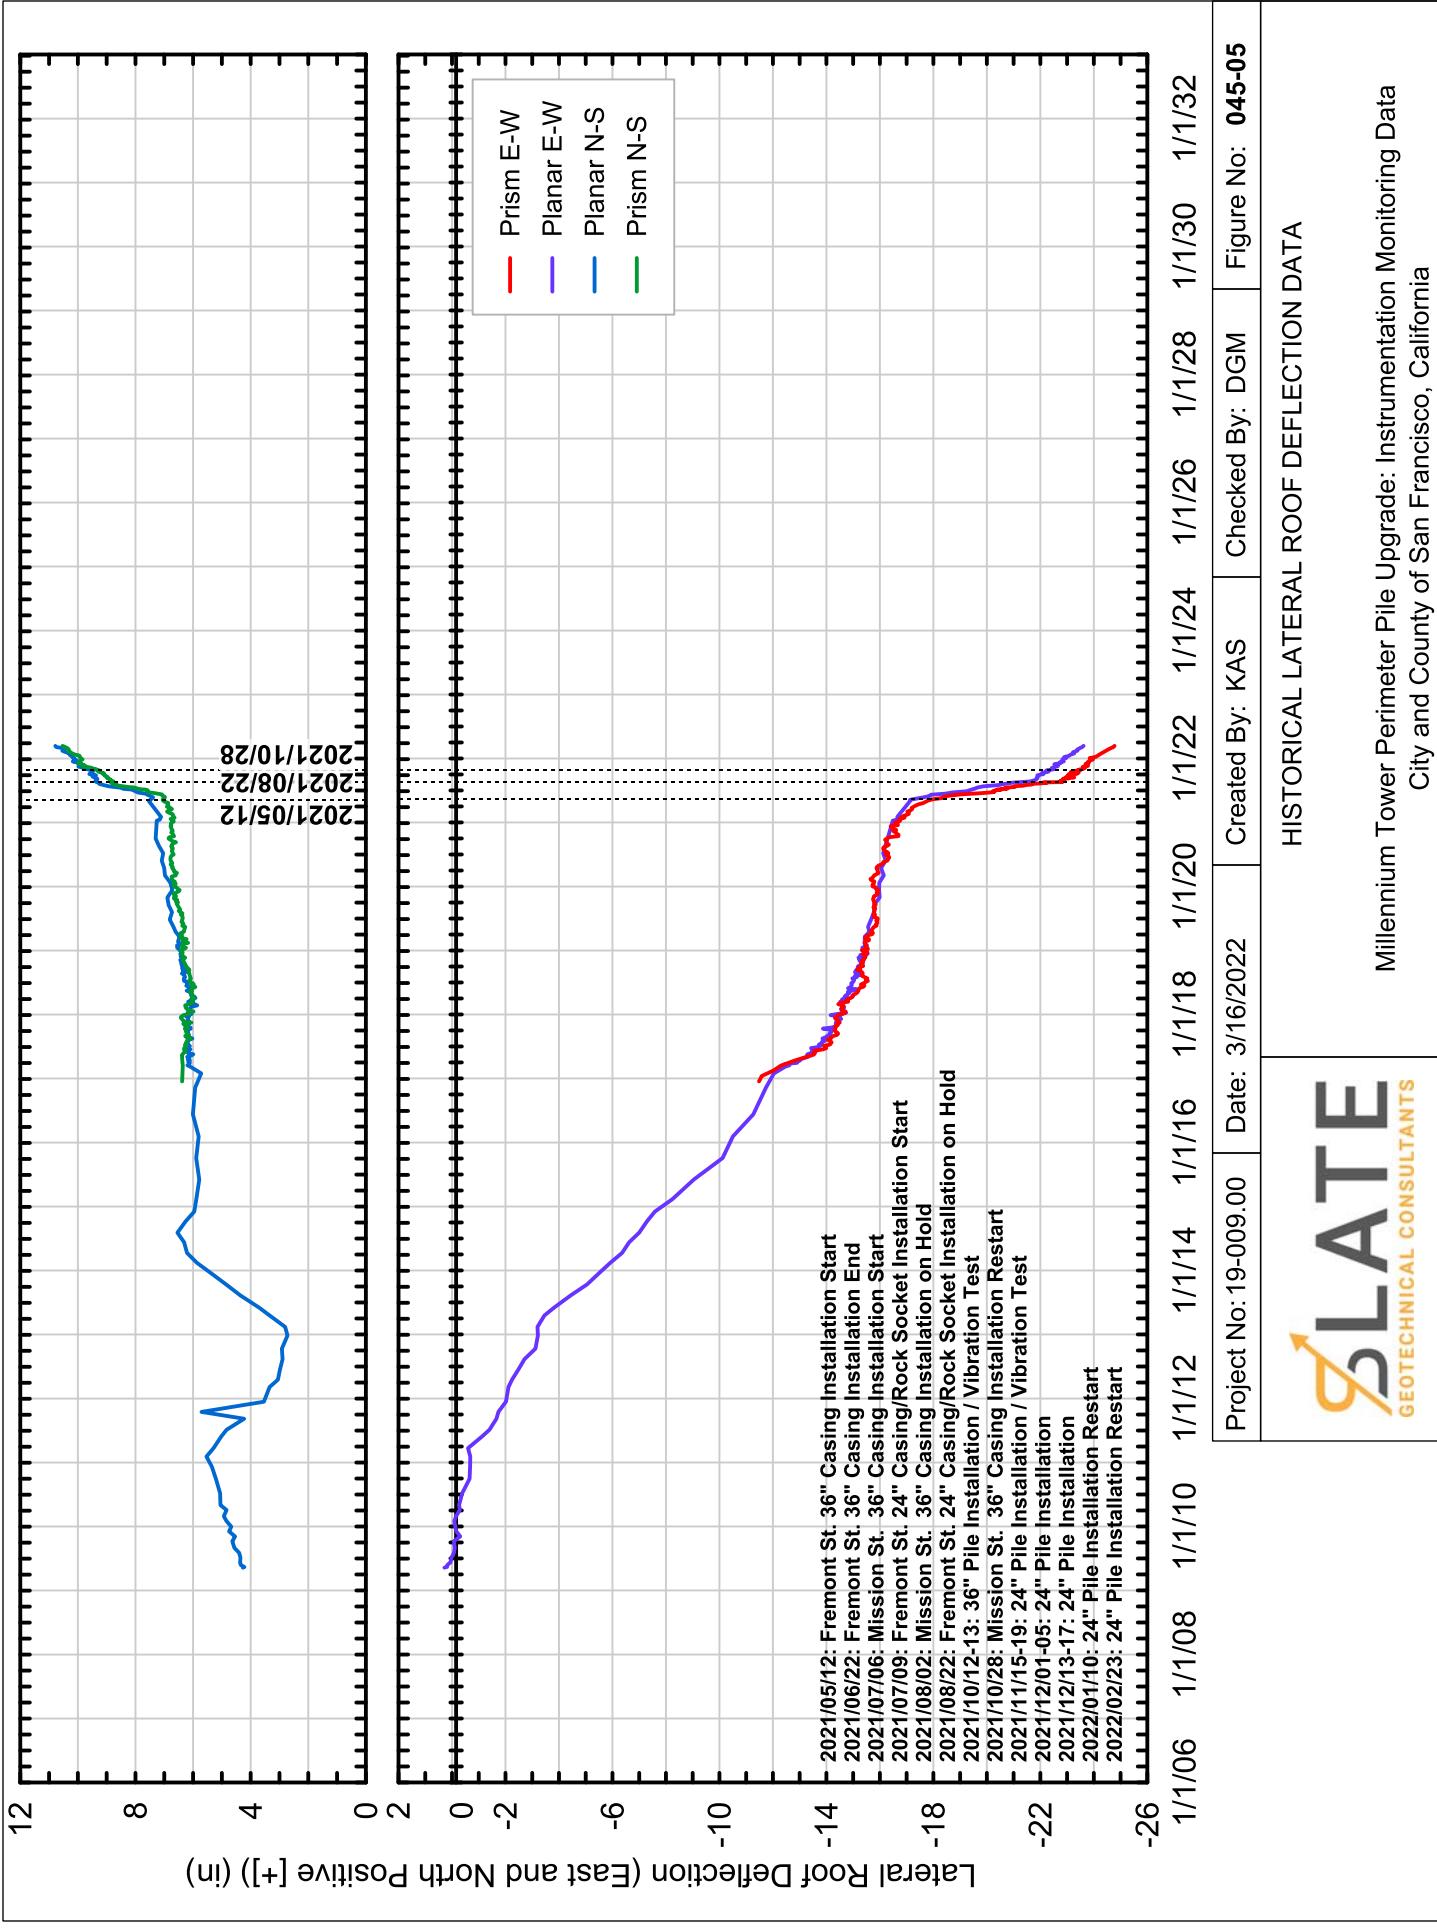
Figure 05 presents historical lateral roof deflections in the project north-south and project east-west directions interpreted from survey prisms mounted on the exterior of the Tower, from InSAR data, and from a planar fit of the settlement marker data. In addition, data from surveys performed during the retrofit are included. Figure 06A presents lateral roof deflection data from a planar fit of the settlement marker data and from survey prisms mounted on the exterior of the Tower since the start of production pile installation (May 12, 2021; baseline readings on May 10 and 13, 2021, respectively) through March 14, 2022. Figure 06B presents lateral roof deflection data from a planar fit of the settlement marker data and from survey prisms mounted on the exterior of the Tower since January 11, 2021, through March 14, 2022.

- Figure 05 – Historical Lateral Roof Deflection Data
- Figure 06A – Lateral Roof Deflection Data since 05/10/2021 through 03/14/2022
- Figure 06B – Lateral Roof Deflection Data since 01/11/2021 through 03/14/2022

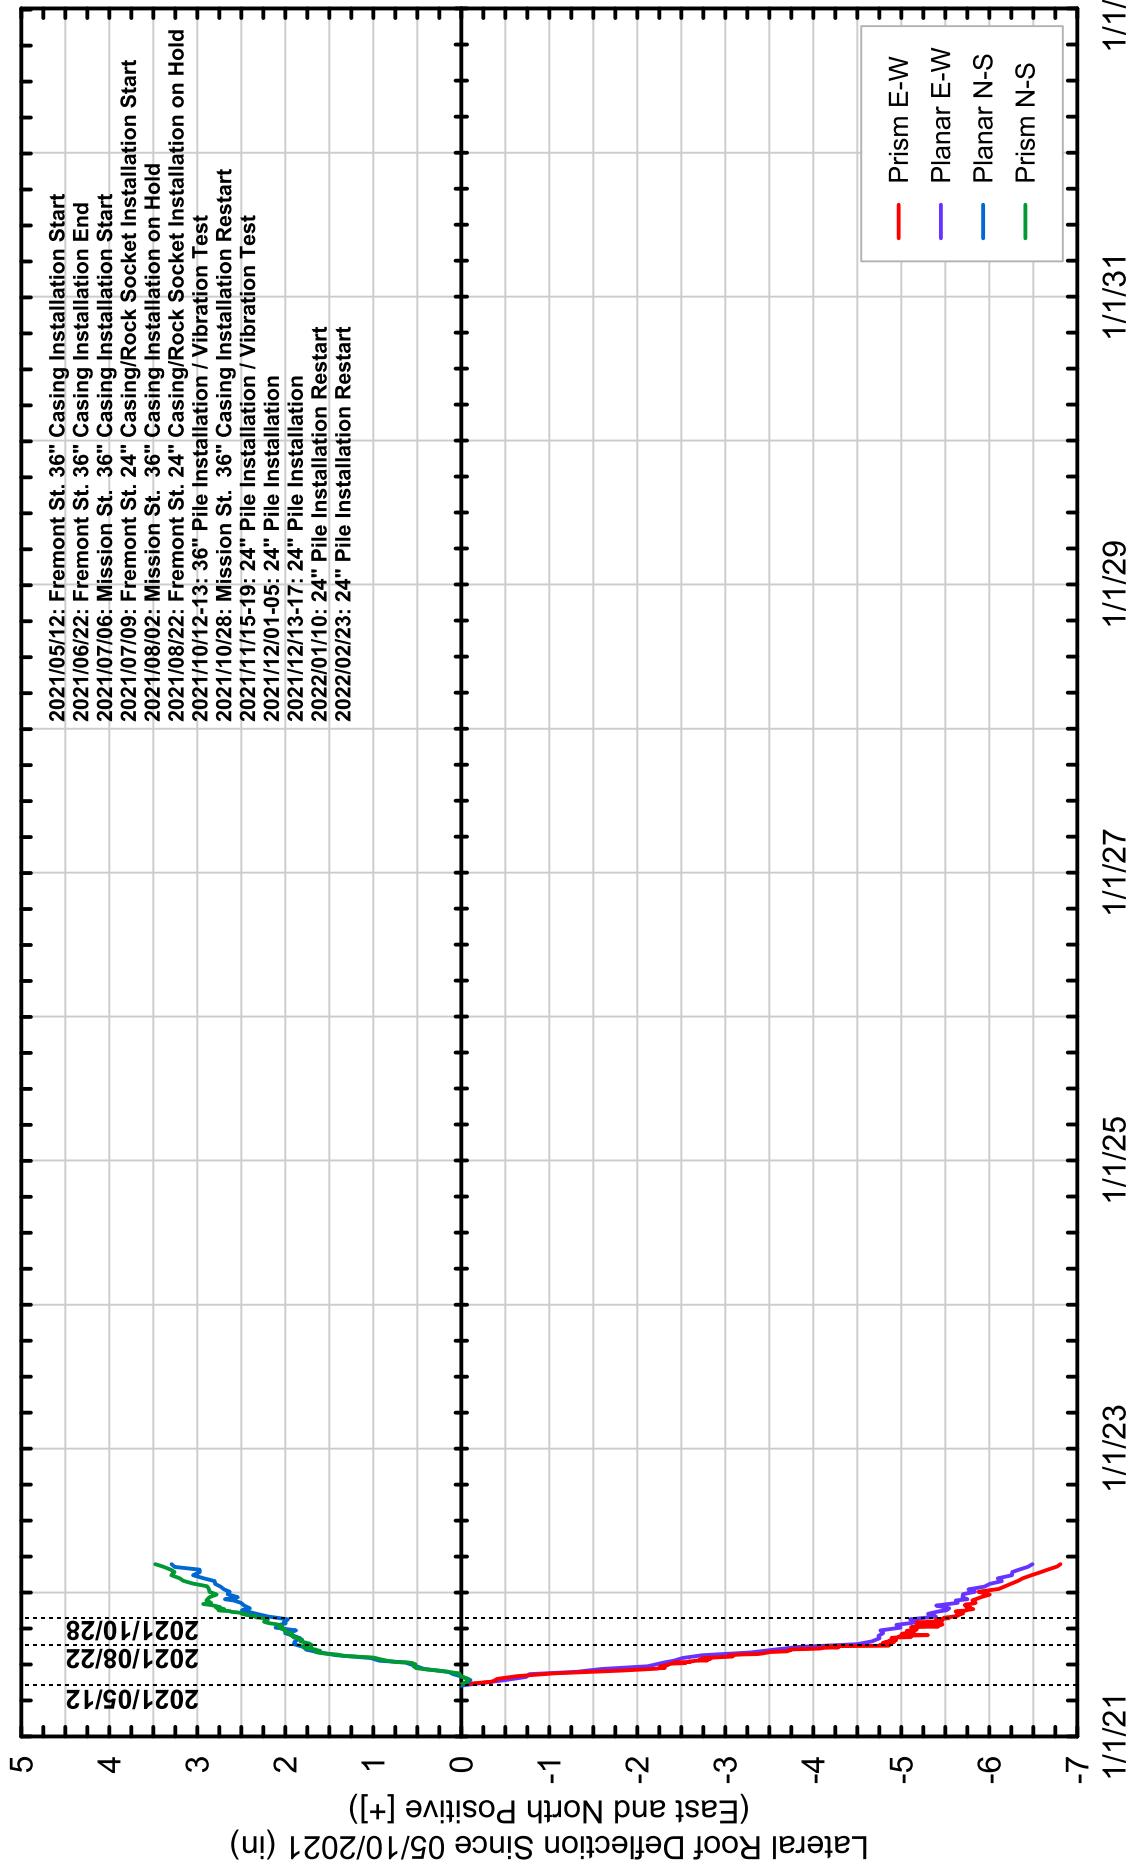
LATERAL ROOF DEFLECTION DATA SINCE 05/10/2021 THROUGH 03/14/2022				1/1/33
Millennium Tower Perimeter Pile Upgrade: Instrumentation Monitoring Data City and County of San Francisco, California

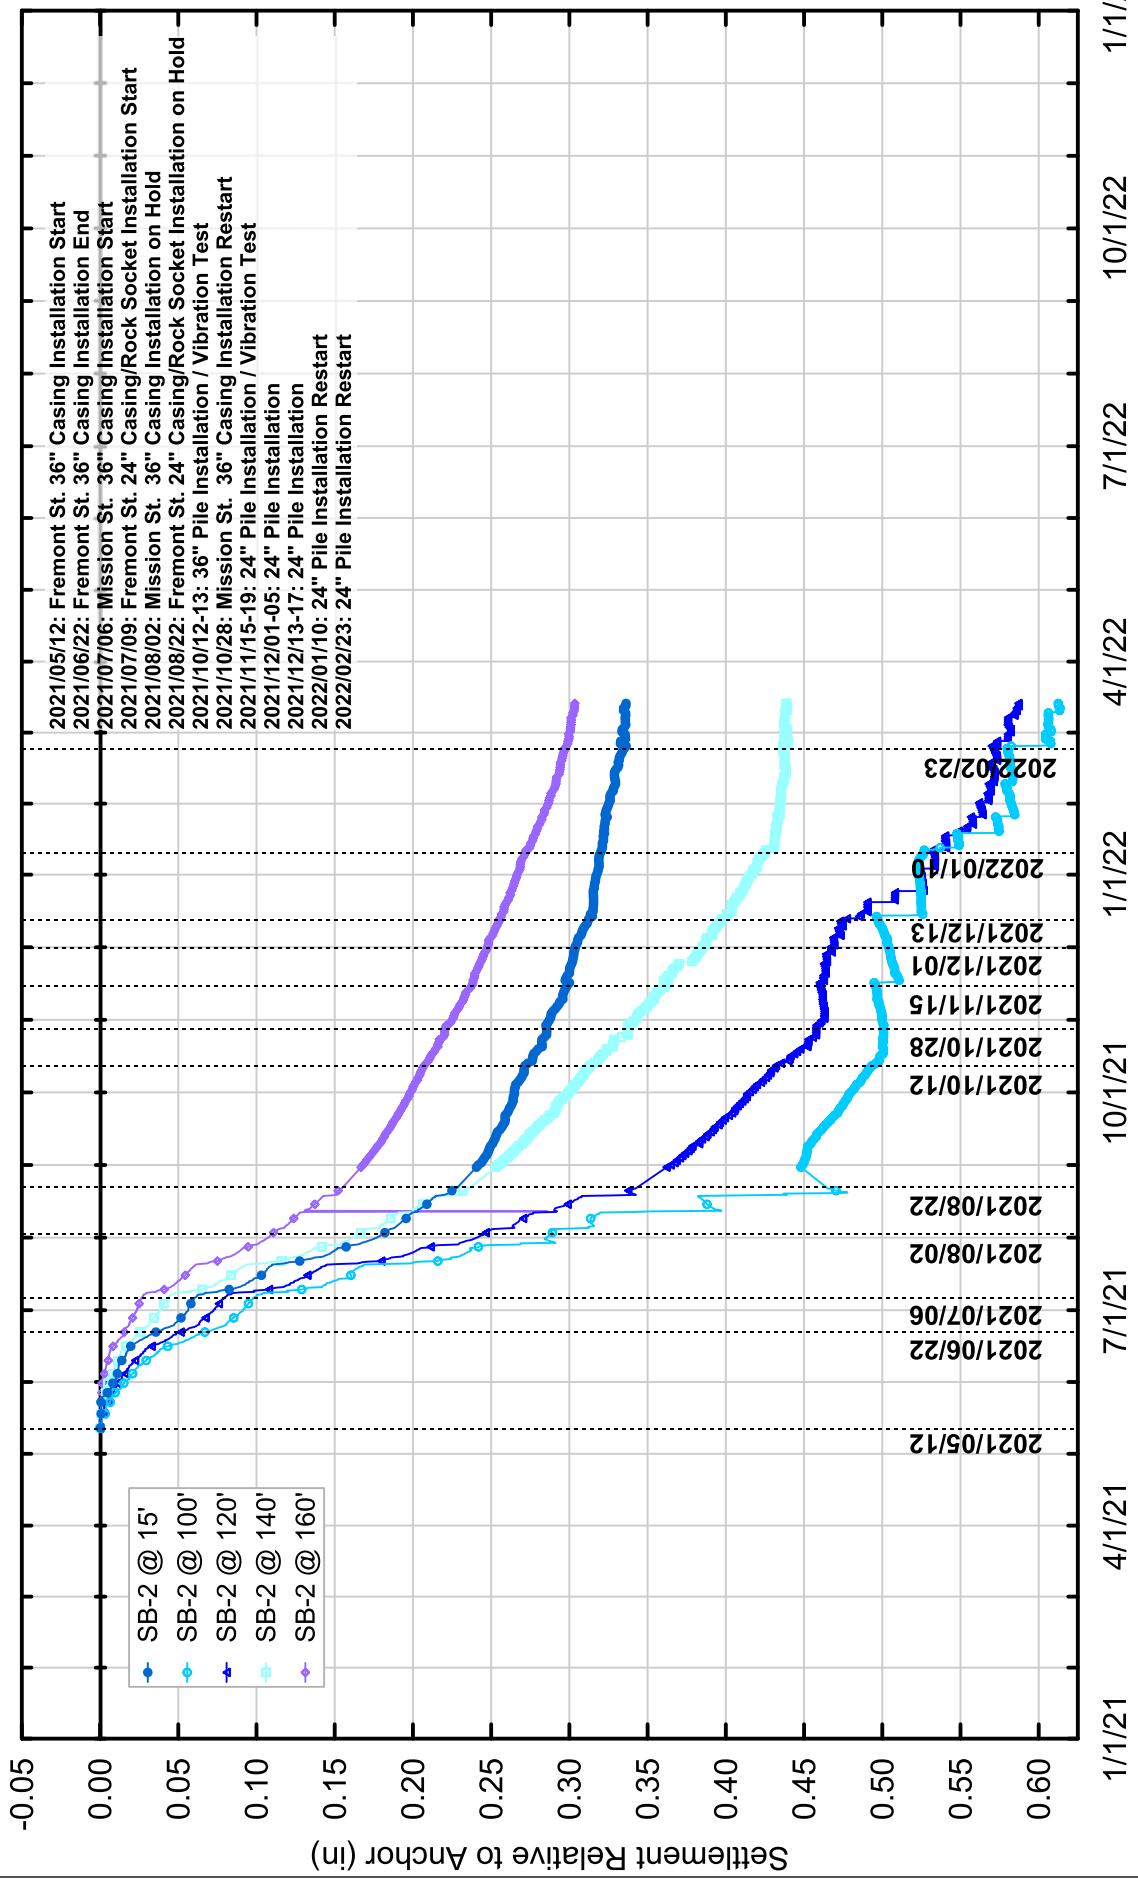
Project No: 19-009.00	Date: 3/16/2022	Created By: KAS	Checked By: DGM	Figure No: 045-10A
EXTENSOMETER DATA FROM WITHIN TOWER BASEMENT SINCE 01/01/2021 THROUGH 03/14/2022

Figure 10 presents extensometer data from within the Tower basement since the start of production pile installation (May 12, 2021) through March 14, 2022. Figure 11 presents extensometer data from Fremont Street since the start of production pile installation (May 12, 2021) through March 12, 2022. Figure 12 presents extensometer data from Mission Street since the start of production pile installation (May 12, 2021) through March 15, 2022.

- Figure 09B – Groundwater Elevation Measurements in Old Bay Clay since 01/01/2021 through 03/15/2022
- Figure 10A – Extensometer Data from within Tower Basement since 01/01/2021 through 03/14/2022

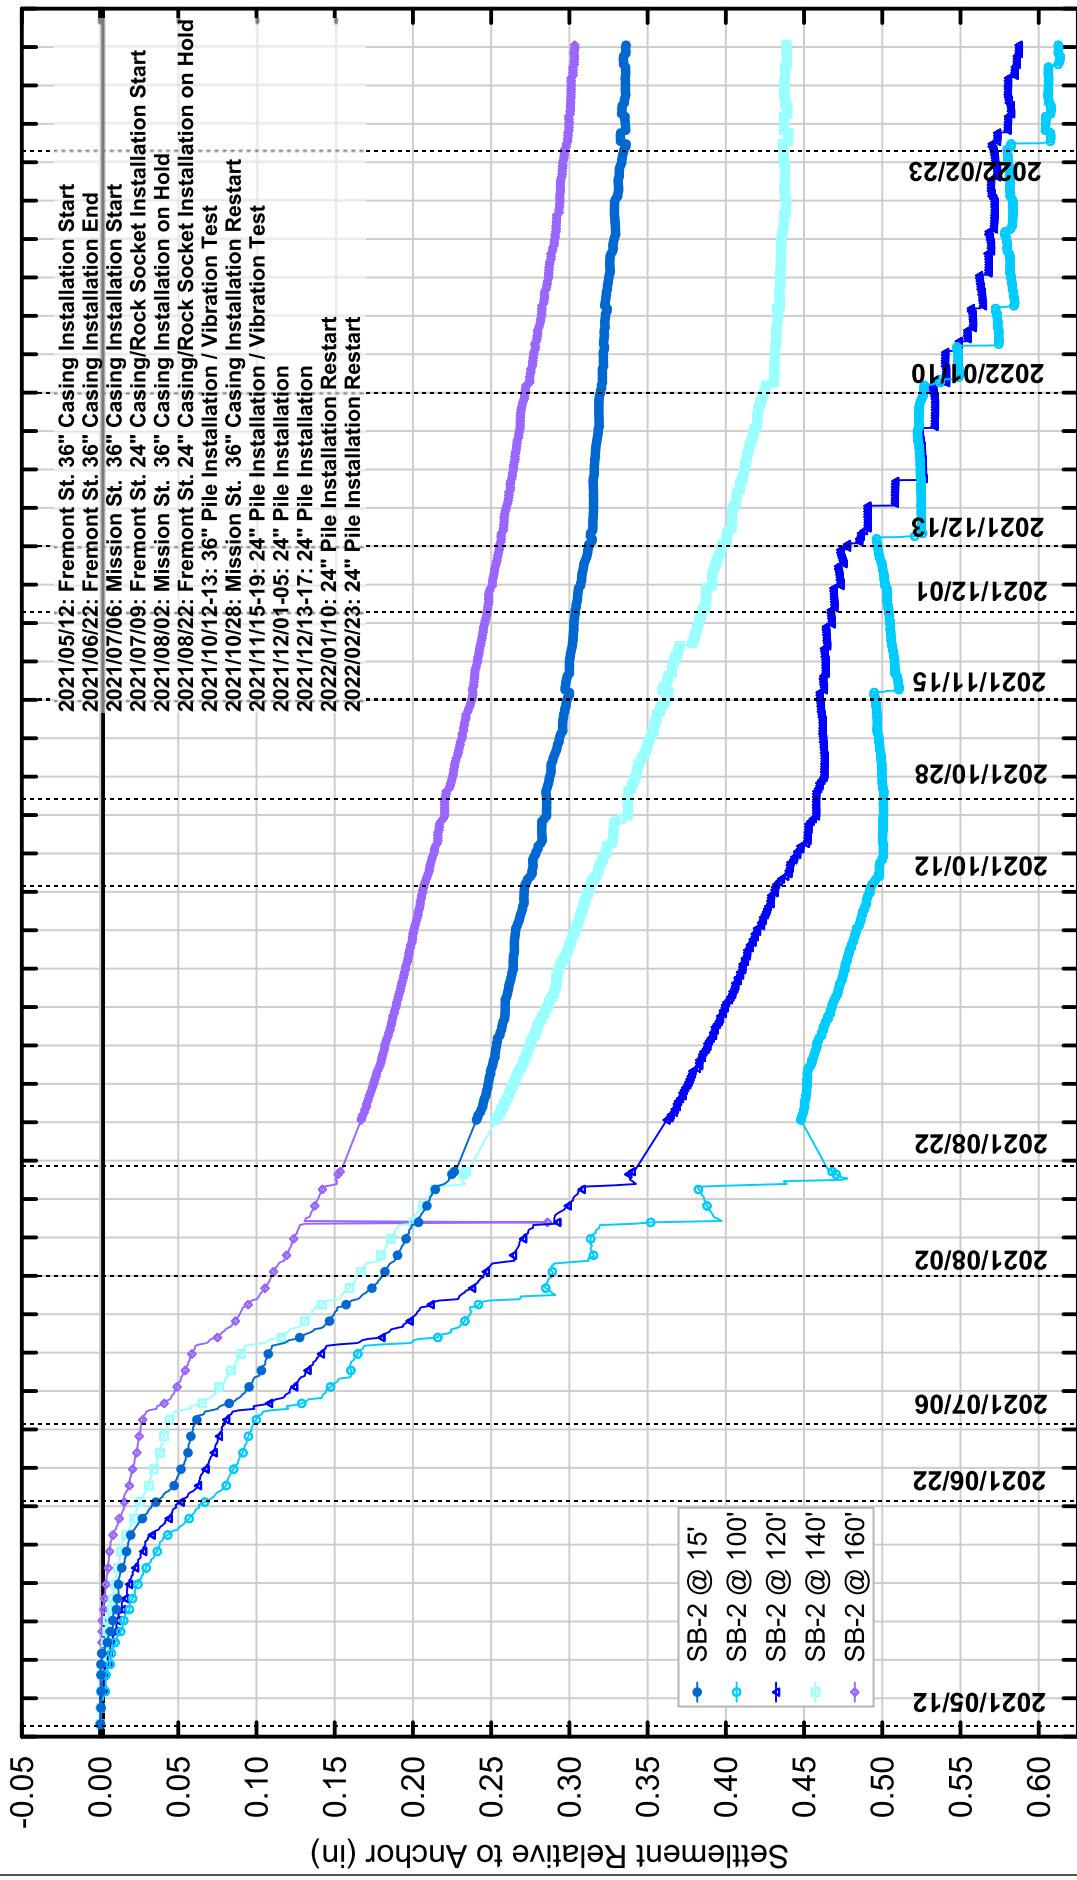
Project No: 19-009.00	Date: 3/16/2022	Created By: KAS	Checked By: DGM	Figure No: 045-10B
-----------------------	-----------------	-----------------	-----------------	--------------------

2021/05/12
2021/06/22
2021/07/06
2021/07/09
2021/08/02
2021/08/22
2021/10/12-13
2021/10/28
2021/11/15-19
2021/12/01-05
2021/12/13-17
2022/01/10
2022/02/23

EXTENSOMETER DATA FROM WITHIN TOWER BASEMENT
SINCE 05/10/2021 THROUGH 03/14/2022

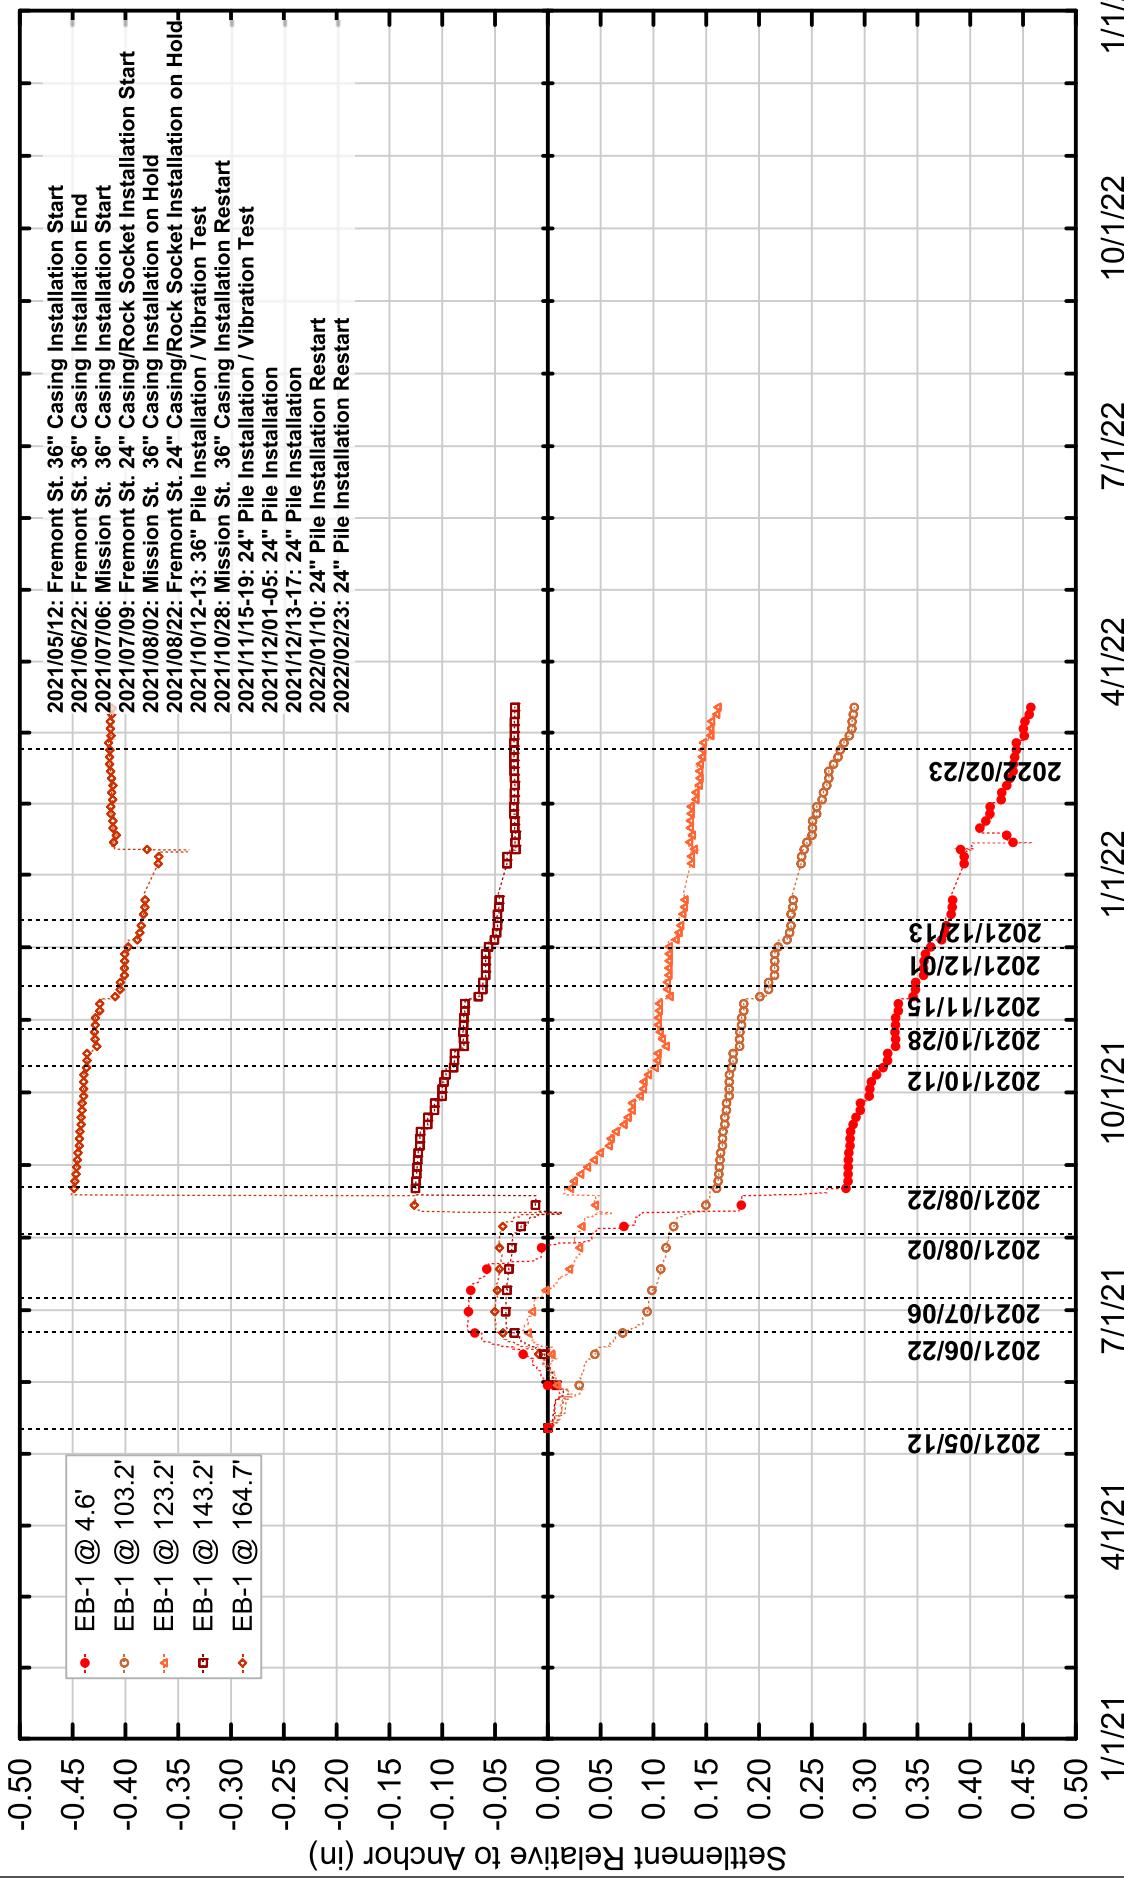
Project No: 19-009.00	Date: 3/16/2022	Created By: KAS	Checked By: DGM	Figure No: 045-11A
EXTENSOMETER DATA FROM FREMONT STREET SINCE 01/01/2021 THROUGH 03/12/2022

- Figure 10B – Extensometer Data from within Tower Basement since 05/10/2021 through 03/14/2022
- Figure 11A – Extensometer Data from Fremont Street since 01/01/2021 through 03/12/2022

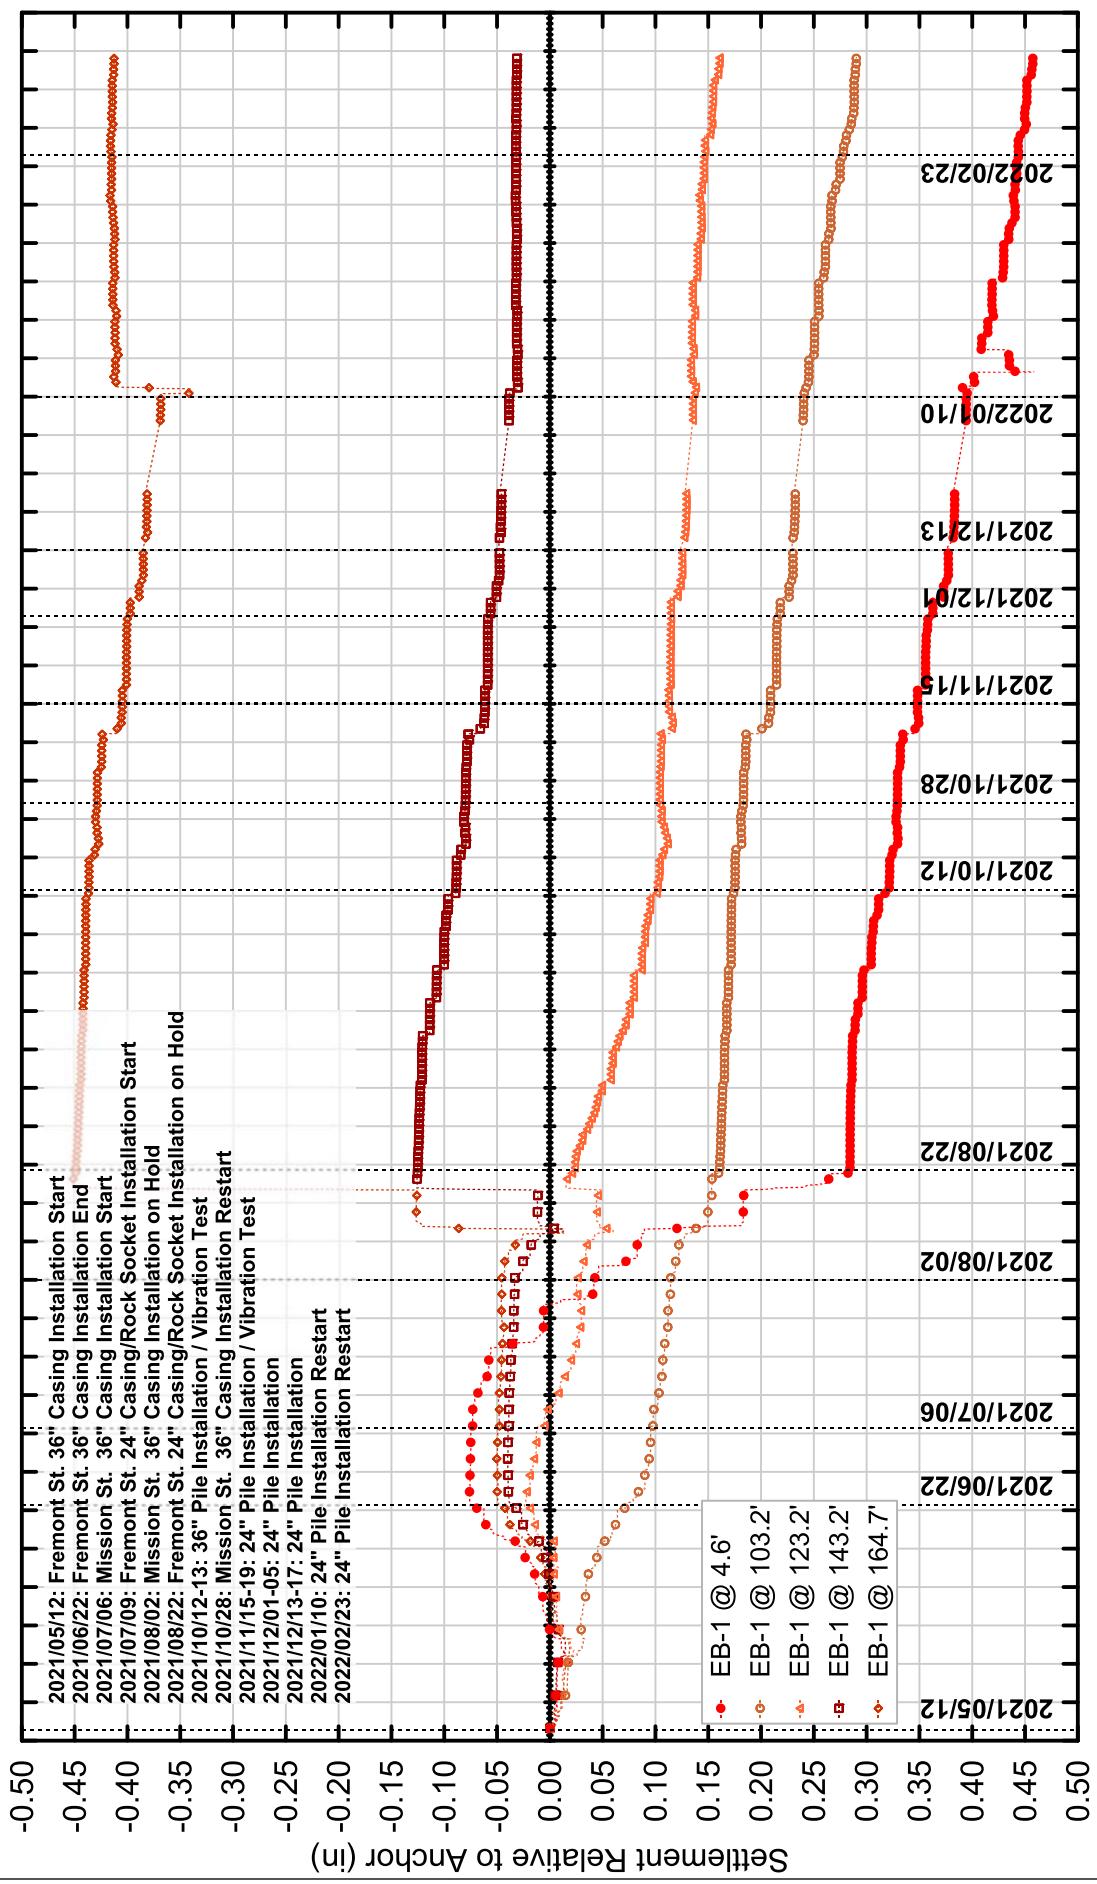
Project No: 19-009.00	Date: 3/16/2022	Created By: KAS	Checked By: DGM	Figure No: 045-11B
-----------------------	-----------------	-----------------	-----------------	--------------------

2021/05/12
2021/06/22
2021/07/06
2021/07/09
2021/08/02
2021/08/22
2021/10/12-13
2021/10/28
2021/11/15-19
2021/12/01-05
2021/12/13-17
2022/01/10
2022/02/23

EXTENSOMETER DATA FROM FREMONT STREET
SINCE 05/10/2021 THROUGH 03/12/2022

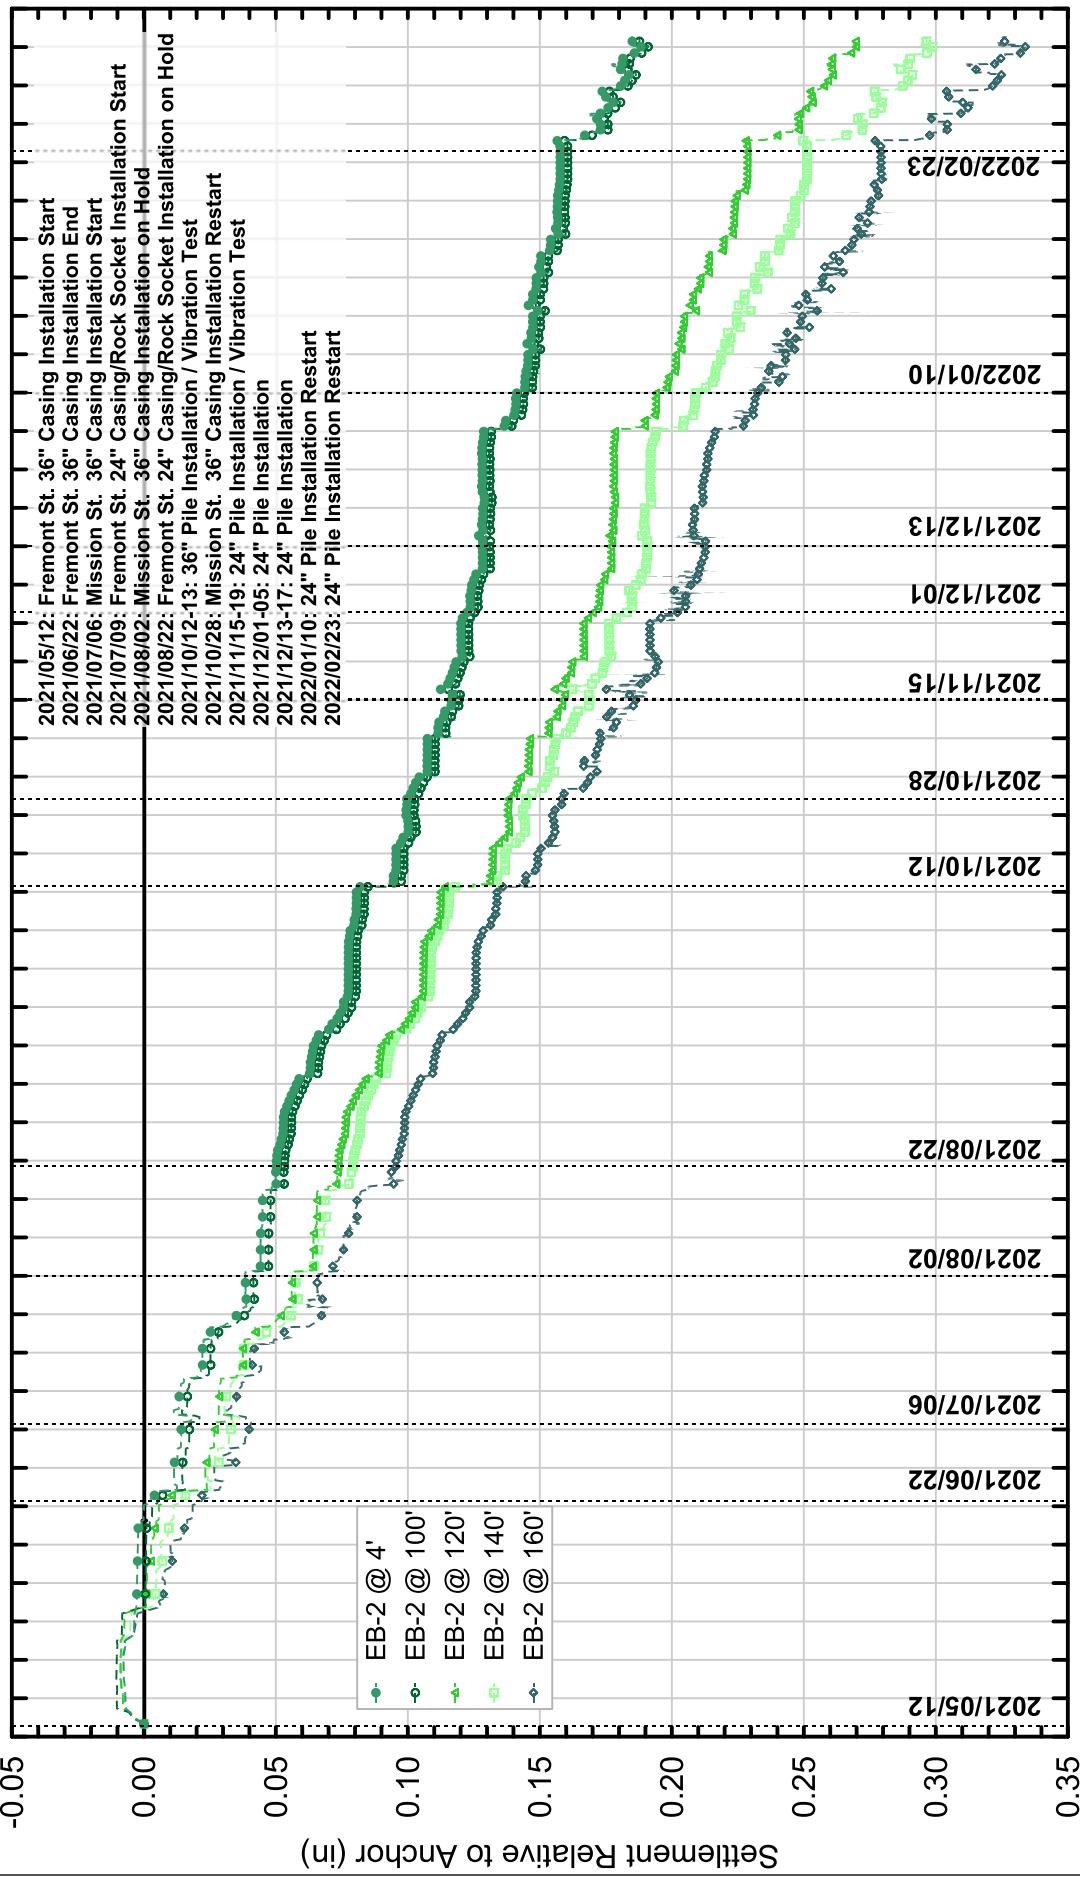
Project No: 19-009.00	Date: 3/16/2022	Created By: KAS	Checked By: DGM	Figure No: 045-12B
-----------------------	-----------------	-----------------	-----------------	--------------------

2021/05/12: Fremont St. 36" Casing Installation Start
 2021/06/22: Fremont St. 36" Casing Installation End
 2021/07/06: Mission St. 36" Casing Installation Start
 2021/07/09: Fremont St. 24" Casing/Rock Socket Installation Start
 2021/08/02: Mission St. 36" Casing/Rock Socket Installation on Hold
 2021/08/22: Fremont St. 24" Casing/Rock Socket Installation on Hold
 2021/10/12-13: 36" Pile Installation / Vibration Test
 2021/10/28: Mission St. 36" Casing Installation Restart
 2021/11/15-19: 24" Pile Installation / Vibration Test
 2021/12/01-05: 24" Pile Installation
 2021/12/13-17: 24" Pile Installation
 2022/01/10: 24" Pile Installation Restart
 2022/02/23: 24" Pile Installation Restart

EXTENSOMETER DATA FROM MISSION STREET
 SINCE 05/10/2021 THROUGH 03/15/2022
