Liquid & Plastic Limits

<p>LAWRENCE B. KARP CONSULTING GEOTECHNICAL ENGINEER 100 TRES MESAS ORINDA, CALIFORNIA 94563 (925) 254-1222</p>	PLASTICITY		
	Sterbentz Residence Slope Failure Investigation 24 Saint Hill Road. Orinda		
	DATE	PROJECT	FIGURE: C
	July 2006	206036

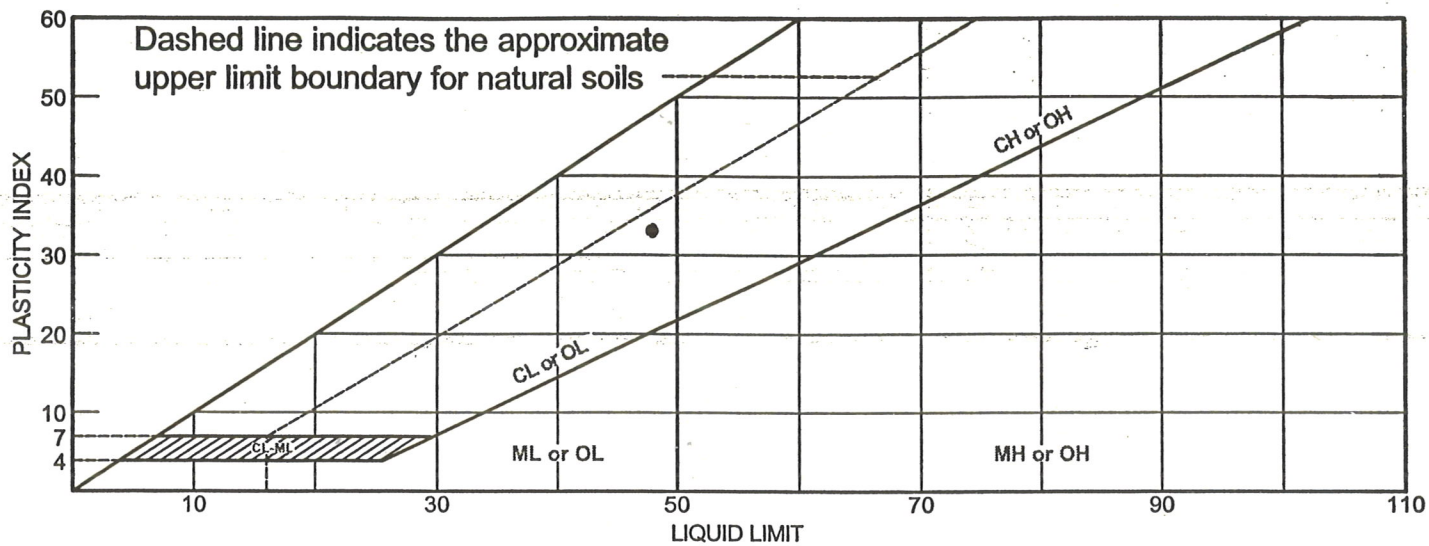
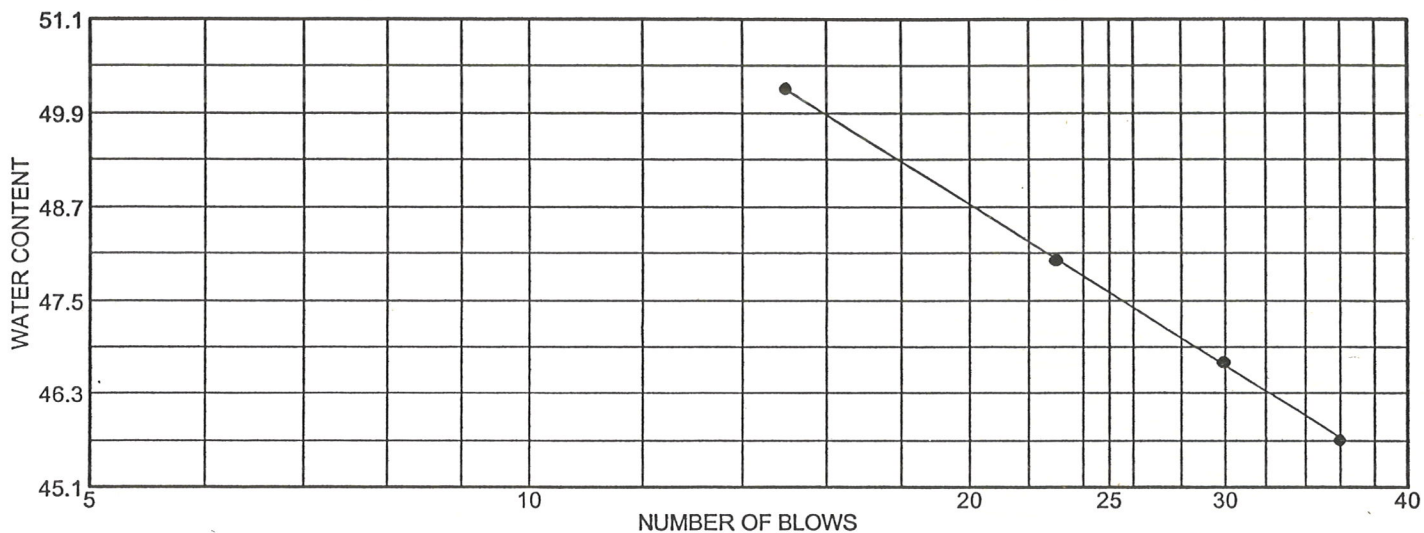
MATERIAL DESCRIPTION	LL	PL	PI	%<#40	%<#200	USCS
● CLAY (see Exploratory Boring Log)	48	15	33	92.3	77.6	CL
